# Blanchard Pond Watershed Study

Evaluation of Blanchard Pond &  
Downstream System and associated Sub-  
watersheds for Removal of Phosphorus

Submitted to: Lake Auburn Watershed  
Protection Commission

February 18, 2021  
Final Report

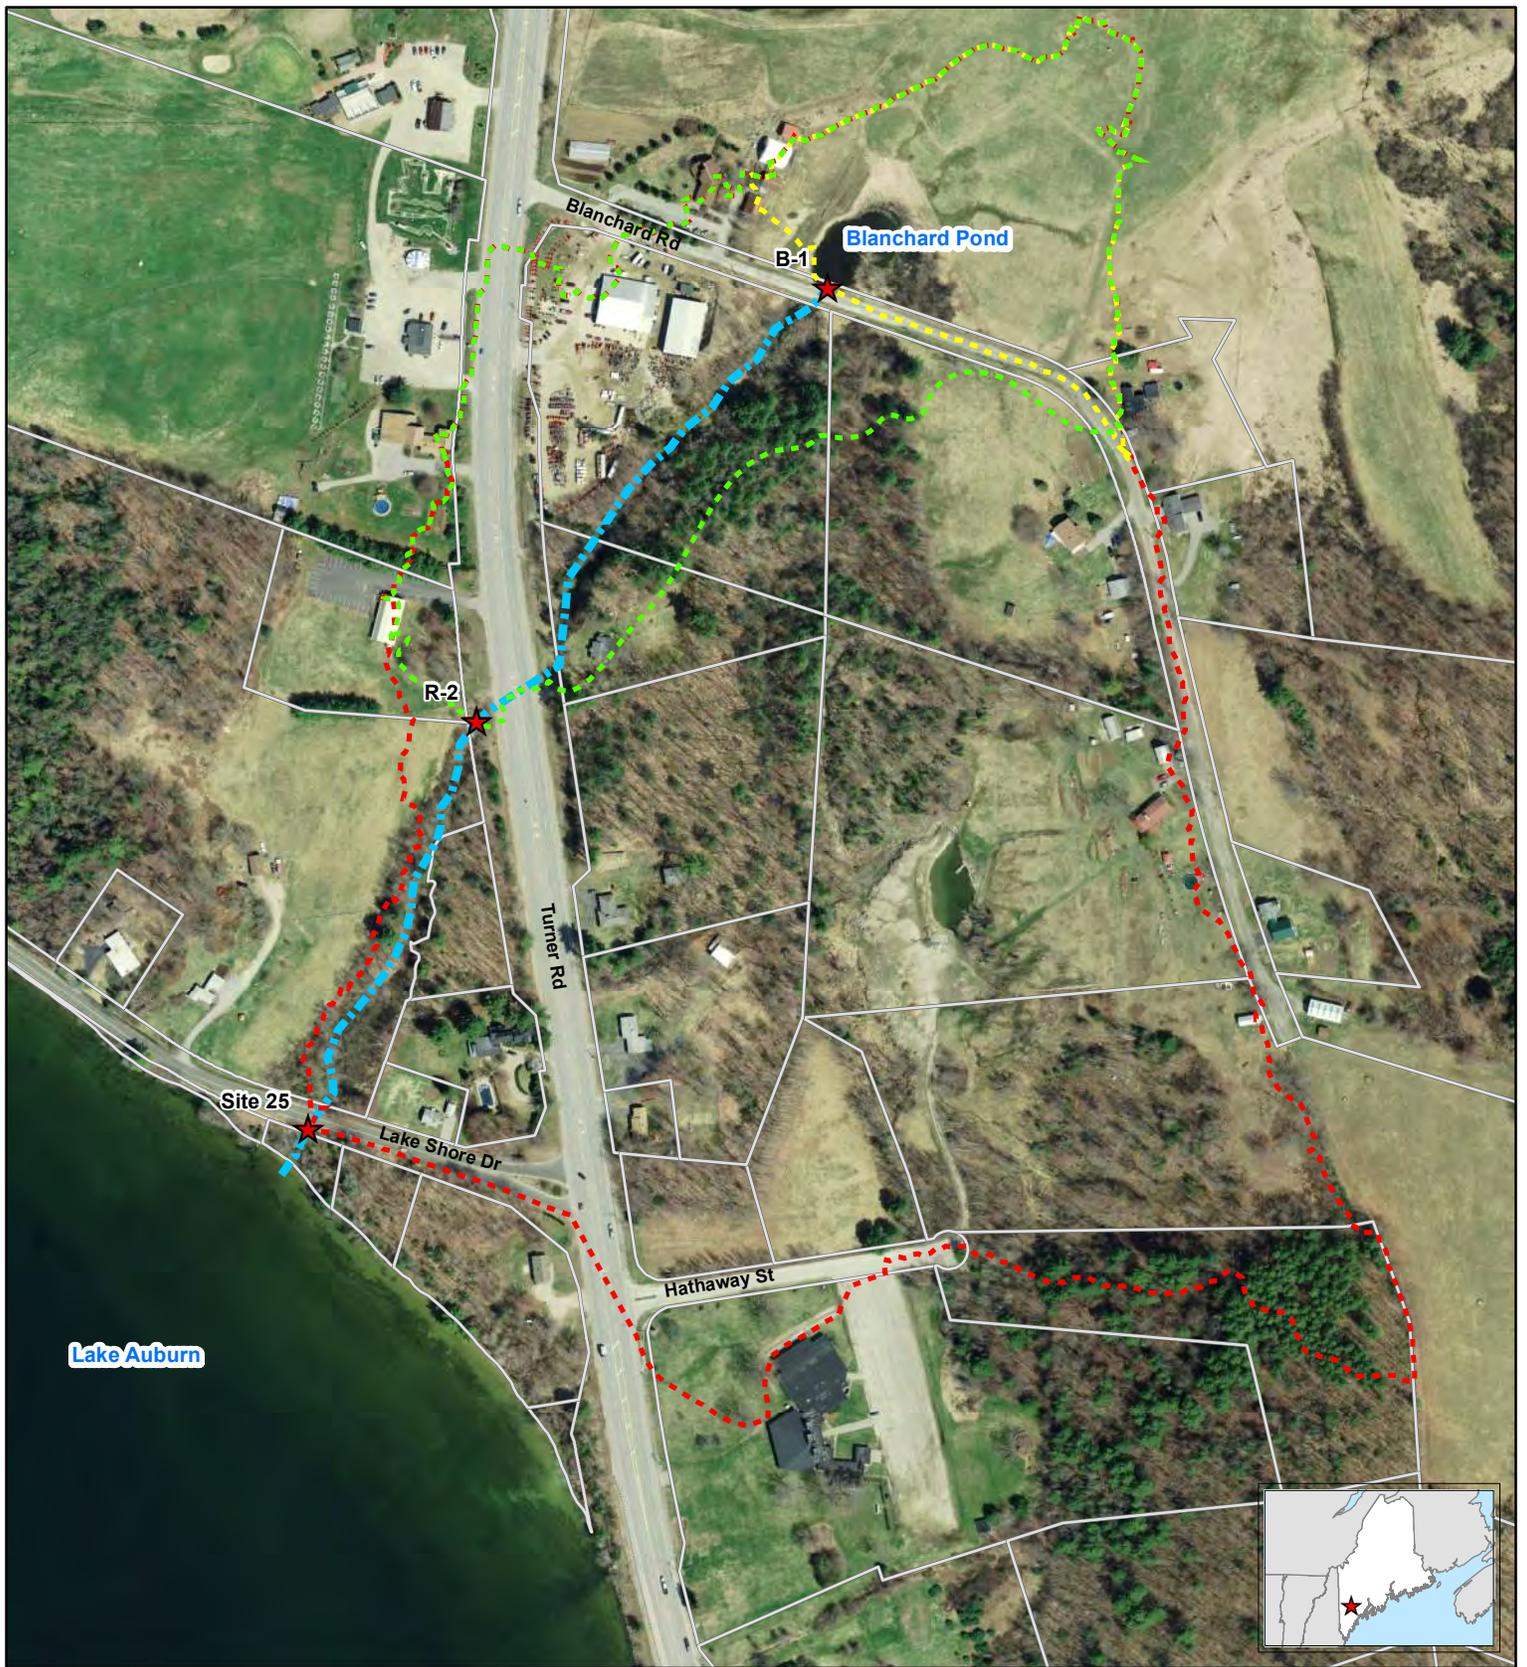
**FIGURE 2-1**  
**BLANCHARD POND WATER**  
**QUALITY AND STREAMFLOW**  
**MEASUREMENT SITES**

Figure 2-1 shows these locations with respect to Blanchard Pond, and provides estimated subwatershed boundaries. Table 2-1 summarizes the watershed areas associated with this system and its segments. For context, Lake Auburn has a watershed area of 9,650 acres. This system comprises less than 1% of the Lake Auburn watershed.

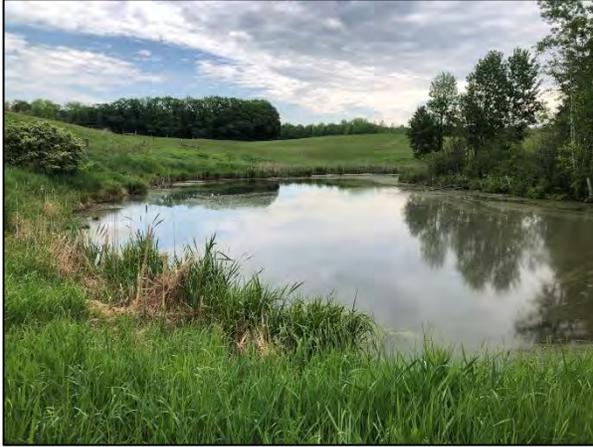
- Historical land use around Blanchard Pond (Photo 1);
- Visible iron oxidation along the streambed (Photos 8 and 15);
- Erosion along Route 4 (Photo 9);
- A private dam visible just upstream of Turner Rd/Route 4 (Photo 10);
- Erosion at Sample Site R-2, evidence of an undersized culvert beneath Route 4 (Photos 11 and 12); and

Photo 1: Northwest-facing view of Blanchard Pond.

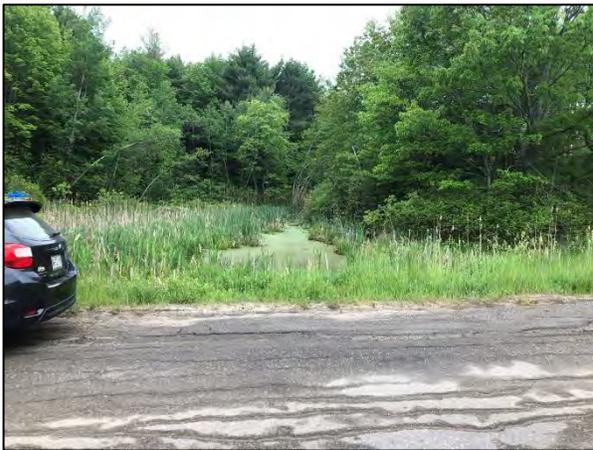
Photo 3: South-facing view of the flooded wetland **downstream of Blanchard Pond**. **The 20" culvert** connecting the pond to this wetland was dry at the time of this photo. Green tint on waterbody is pollen cover, not algae, based on site observations.

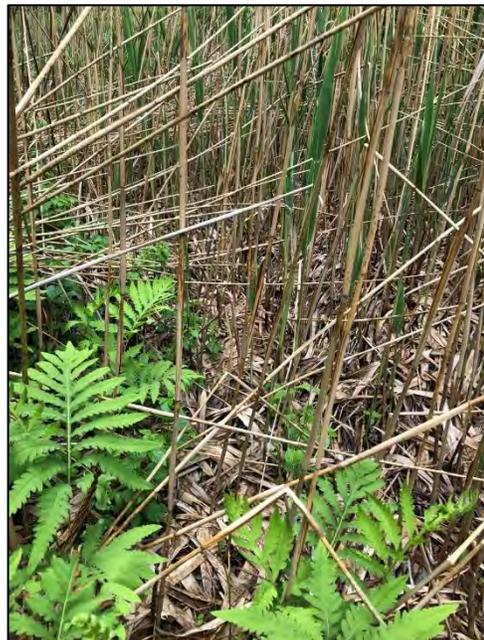
Photo 4: North-facing view from downstream of the flooded wetland. Thick reed growth and detritus heavily obscured the stream bed although no flow was observed.

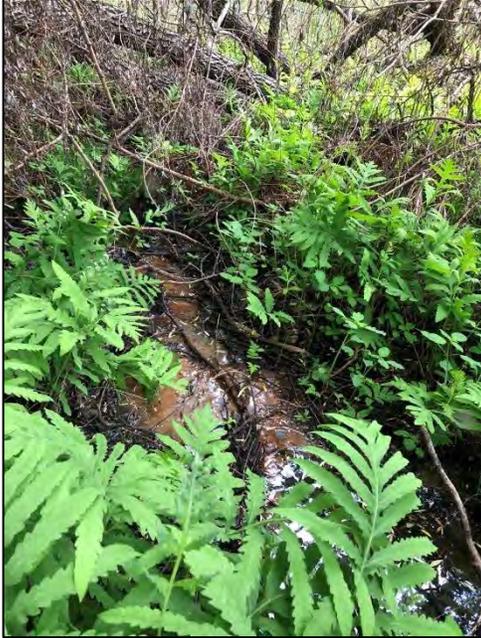
Photo 5: Downstream of the reeds, brownish-red standing water was observed in various pools, no flow was observed.

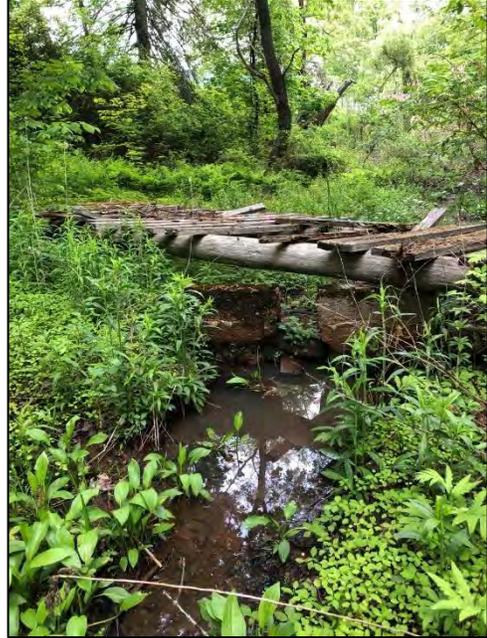
Photo 6: Upstream-facing view of the bridge crossing the stream behind Wallingford Equipment Co. A gravel access road leading to the bridge was observed to the east. Discarded tires and building materials were visible. Standing water did not appear to be flowing.

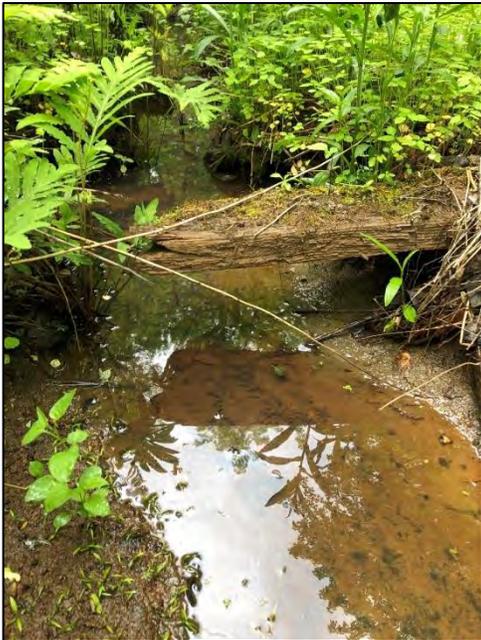
Photo 7: The stream channel immediately downstream of the bridge showed characteristics of high-flow, evidence by a relatively straight channel with dual bank erosion. This stream morphology was visible for approximately 70 ft before establishing a meandering channel.

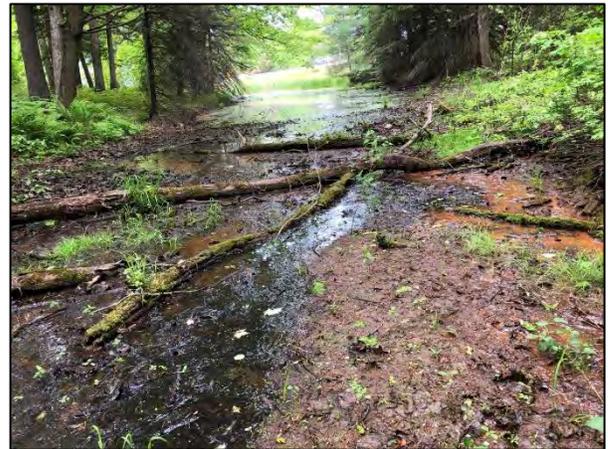
Photo 8: The stream again becomes a flooded wetland before crossing Route 4.

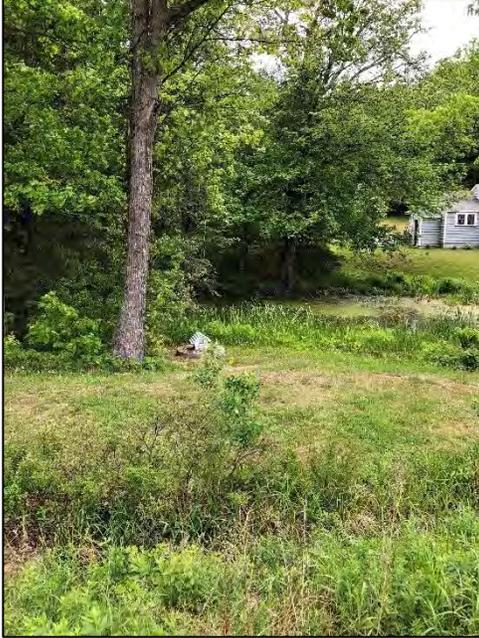
Photo 9: An east-facing view from Route 4 showing the flooded wetland prior crossing under the road. Erosion along the side of Route 4 is visible in the foreground and an underground structure of unknown purpose is visible in the center of the photo.

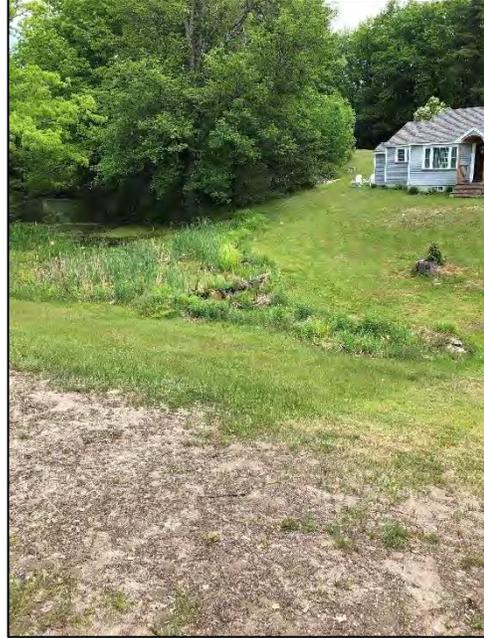
Photo 10: A second east-facing view from Route 4 showing what appears to be a wooden structure damming the stream.

<b>Stream Remediation Alternatives</b>		
<p>Removal of Impoundment on 2481 Turner Road: During the site walk, we observed a <b>small wood "dam" that creates an artificial impoundment</b> at this address. There is potential for significant nutrient development in this part of the system and a heavy rainstorm could flush loads downstream.</p>	\$5,000 to \$7,500	<p>Assumes dam could be removed by hand or with small equipment.</p> <p>Permitting required including wetlands delineation and report, Army Corps Self Verification, Maine NRPA Permit by Rule.</p> <p>Area should be restored, costs associated with that work are included with next item.</p>
<p>Rt. 4 (Turner Rd) Erosion Control &amp; Stream Stabilization: During the site walk, erosion along the northbound shoulder of Rt. 4 (east) was observed. Repair, stabilization, and improved drainage at this location could reduce sediment and nutrient inputs to the Blanchard Pond Stream. In addition, erosion of the stream channel and artificial armoring was observed in the vicinity of Route 4.</p>	\$64,000 to \$115,000	<p>Assumes 400 linear feet upstream and 400 linear feet downstream stabilized (total of 1600 feet of bank), includes stream restoration for 2481 Turner Road as well. Costs depend on actual extent restored, contractor methods, materials use, etc. Permitting required including wetlands delineation, Army Corps PCN, and Maine NRPA Tier 2.</p>

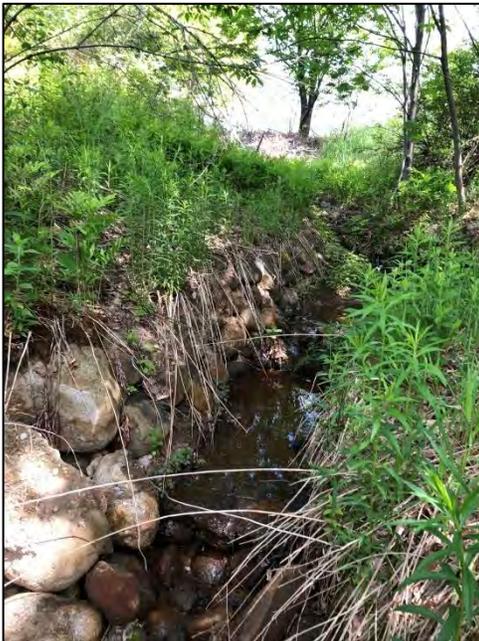
Photo 11: A north-facing view west of Route 4 approximately 10 ft downstream of sample site R-2. An existing rock wall provides bank stabilization directs streamflow south. An eroded slope is visible in the top center of the photo. Standing water was observed in the streambed and culvert.

<p>Rt. 4 (Turner Road) Culvert upsizing: Visible in Photos 11 and 12 (attached), erosion at the culvert outlet west of Rt. 4 provides evidence that the culvert is undersized. <b>Increasing the 24" diameter</b> culvert size and repairing/stabilizing the stream bank at the outlet would help prevent erosion and sediment transport in this part of the stream system. This location has the advantage of being accessible, relative to other parts of the stream, however, Rt. 4 is a state road which could present project challenges, but grants may also be available to perform this work.</p>	Costs are not provided.	<p>Culvert appears to be in satisfactory condition. Due to limited reduction in phosphorus, high cost, and coordination with Maine DOT, alternative not recommended at this time. This could be reexamined if work is proposed in this roadway.</p>

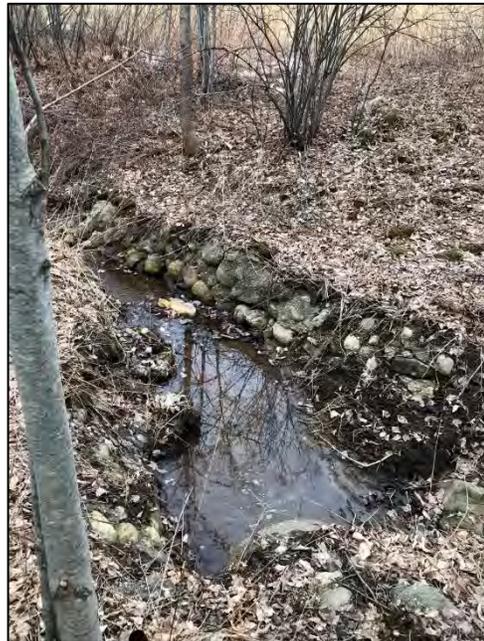
Photo 12: A south-facing view west of Route 4 approximately overlooking sample site R-2. An existing rock wall provides bank stabilization directs streamflow south. The loose soil visible on the right is on the same eroded slope shown in Figure 11. Photo taken 3/9/2020.

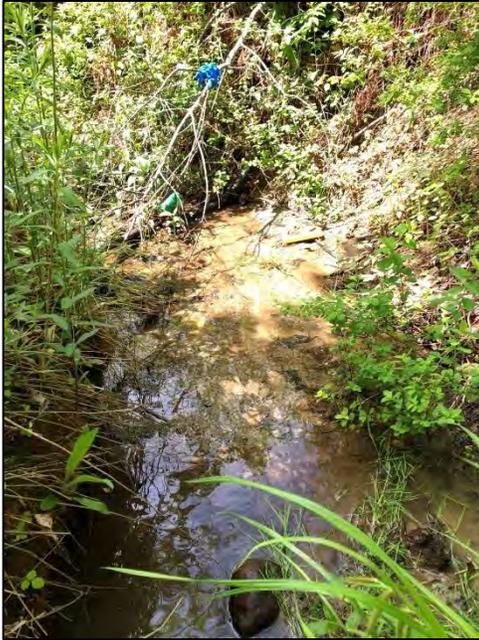
Photo 13: South-facing (downstream) view of the stream approximately 20 ft. The transition from sand to clay is visible in the foreground (refer to Figure 14). This was the first portion of the stream that appeared to be flowing.

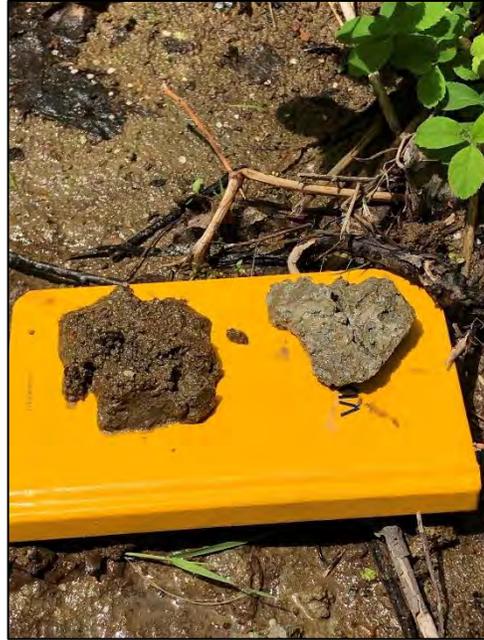
Photo 14: Comparison of streambed deposits upstream (left) and downstream (right) where flow was first observed. Sediment changed from red-brown sand to blue clay. This boundary matches closely with the mapped Presumpscot Formation boundary on the Lake Auburn East Quadrangle Surficial Geology map (Open-File No. 08-72, Maine Geological Survey).

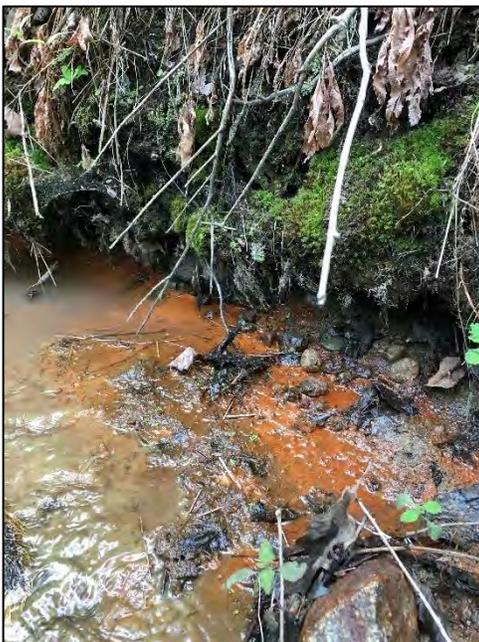
Photo 15: Red deposits, potentially indicating iron oxidation, and stream bed erosion downstream of R-2 with observed stream flow.

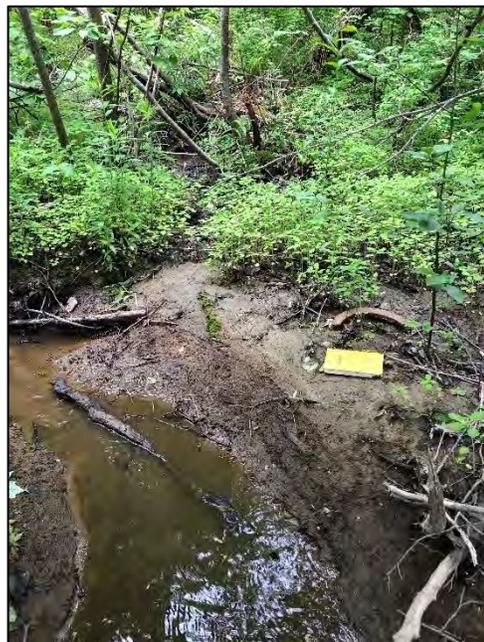
Photo 16: Upstream-facing view of the stream between Route 4 and Lake Shore Drive. Erosion above the water line provides evidence of past flooding.

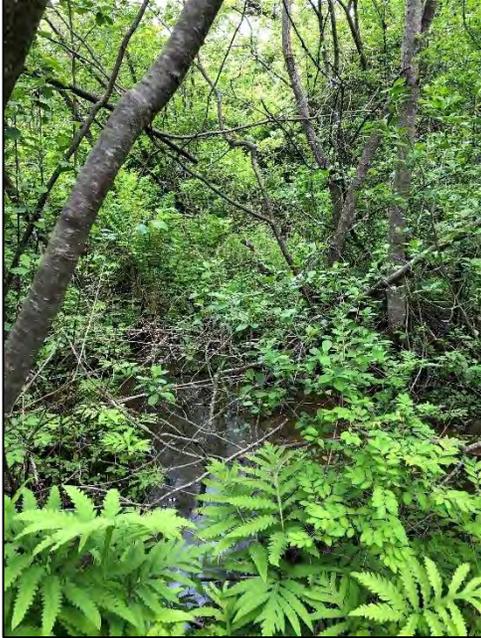
Photo 17: A north-facing (upstream) view from Lake Shore Dr shows a flooded wetland as the stream continues to flow towards the lake.

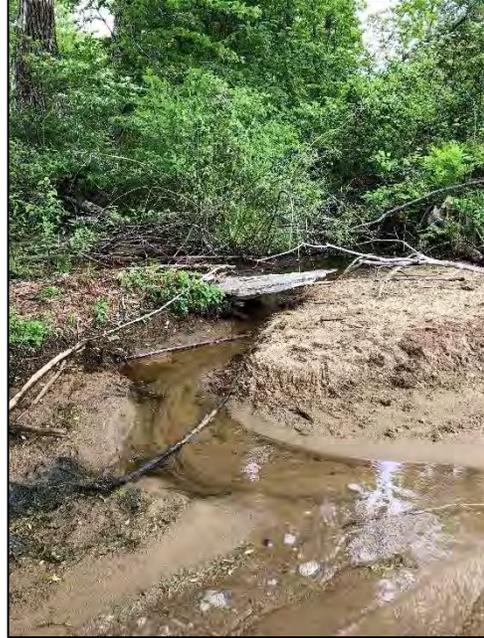
- Beach erosion at the inlet to Lake Auburn (Photo 18).

Photo 18: A north-facing view of the stream as it enters Lake Auburn showing visible erosion of the coarse sand channel.

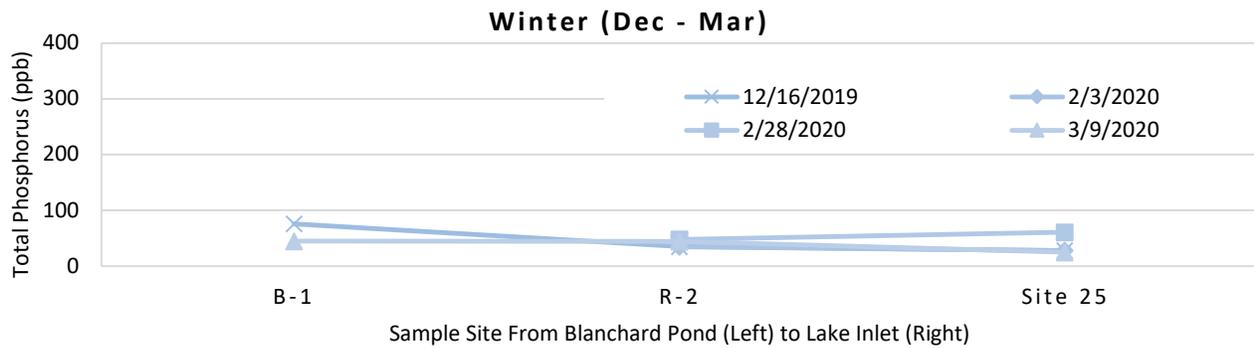
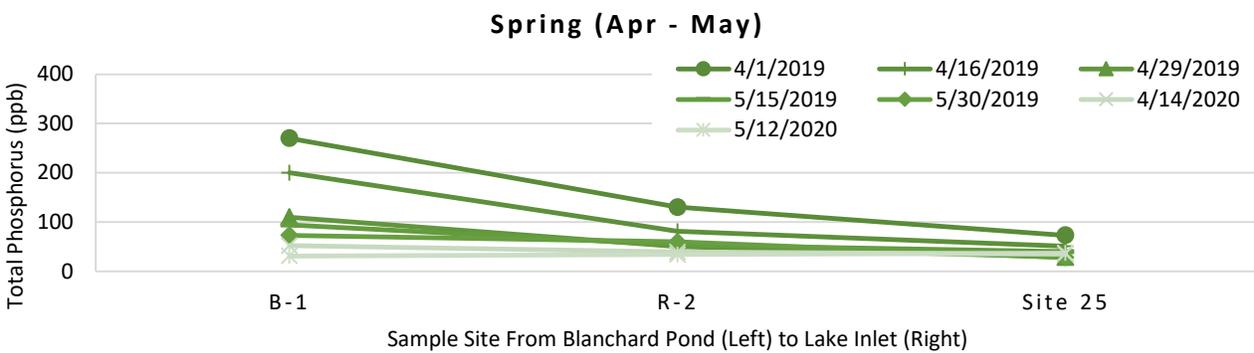
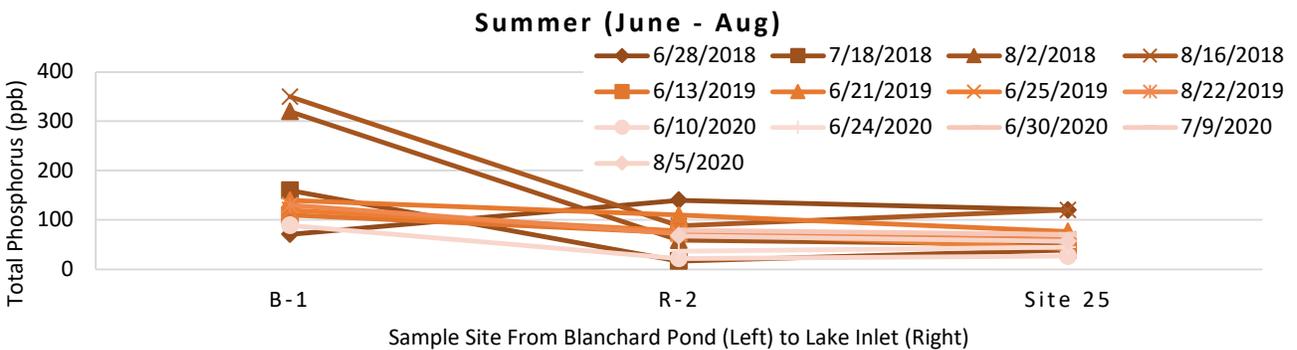
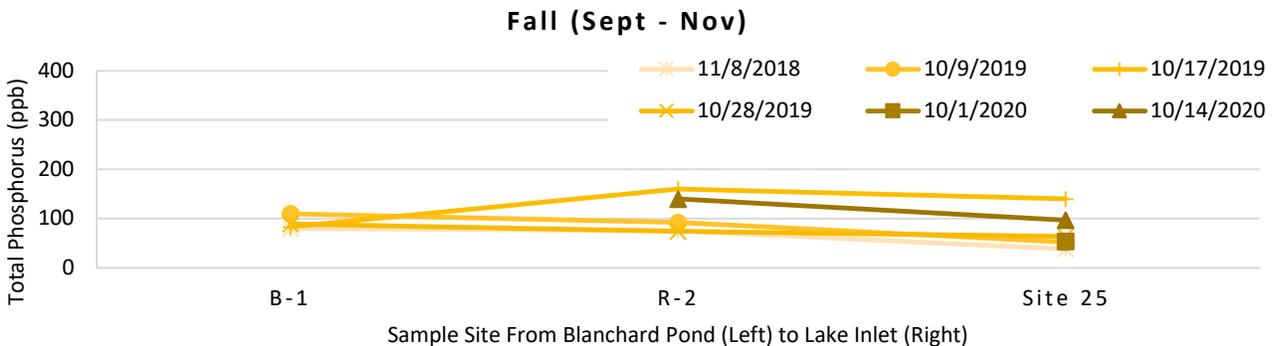
**FIGURE D-1**

Seasonal Total Phosphorus Concentration in Blanchard Pond Stream
