# Lake Auburn Lake Watershed-based Protection Plan

## REPORT

August 2023 (Final)

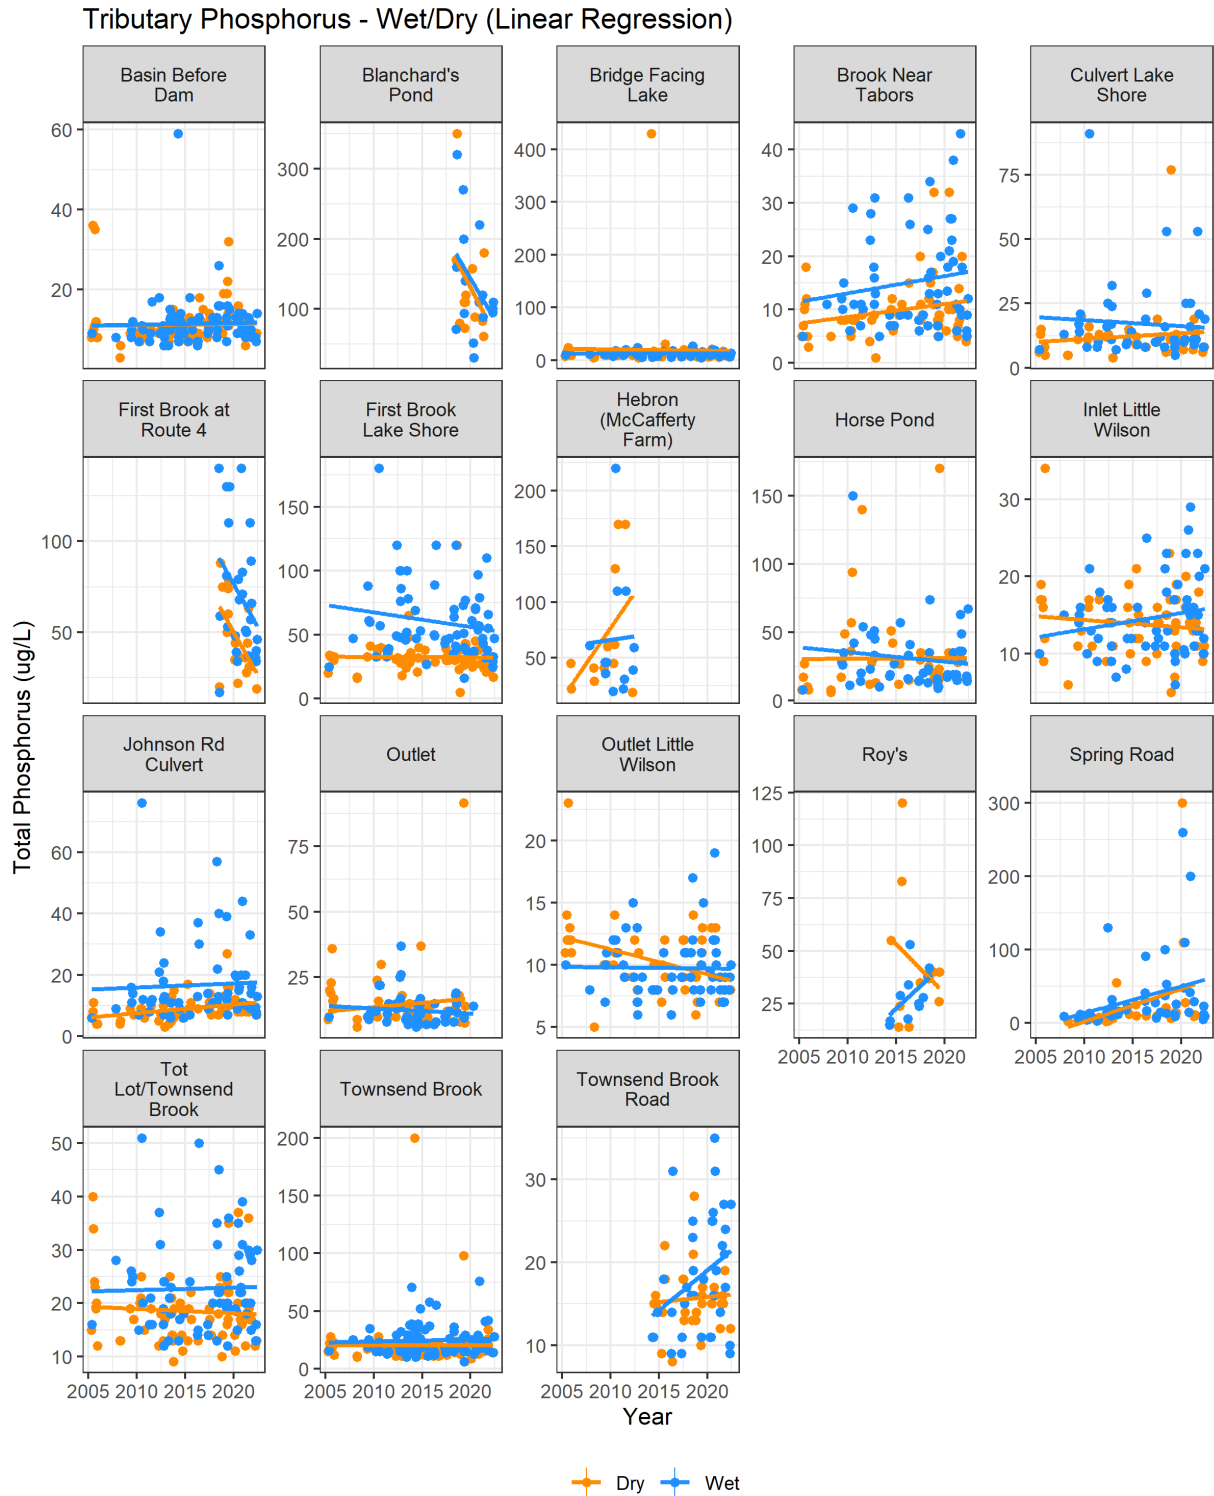
**Figure 2-14**  
**Tributary Monitoring Data – Wet and Dry (2005 through 2022), Linear Regression**  
*Note: the y-axis ranges differ by plot*

A screening-level assessment was first completed using a linear regression of all tributary monitoring data. This assessment was completed for all data aggregated together and then separately for wet and dry weather conditions. Wet weather conditions were broadly defined as those with more than 0.1 inches of precipitation on the day of monitoring. **Figure 2-13** presents all tributary data with a linear regression and **Figure 2-14** presents all tributary data separated into wet and dry conditions with a linear regression. This assessment was conducted to provide a high-level, visual overview of the data, and indicates an apparent increasing trend in concentration at many sites, including Basin Stream, the Brook near Tabers, the Johnson Road Culvert, Spring Road, and Townsend Brook.

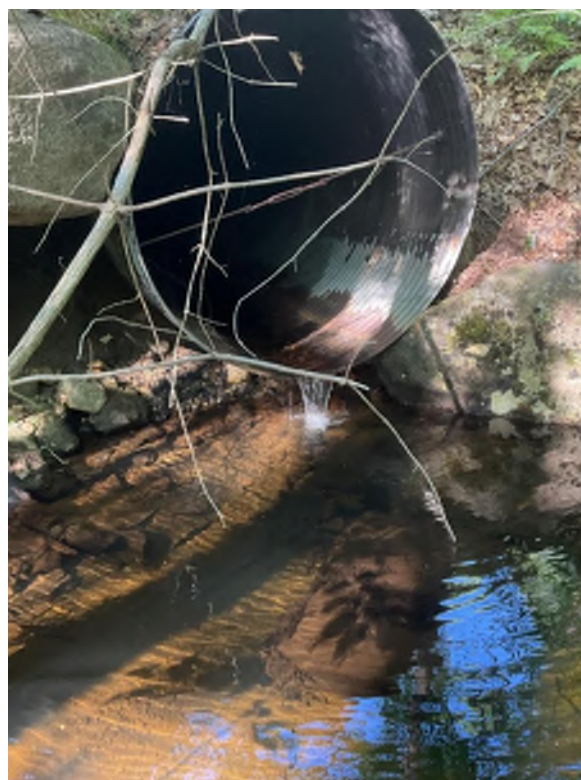
**Figure B-6**  
**Sediment in the Pool Underneath the Culvert Crossing at Lake Shore Drive**

Actions to explore at this location are further investigations into upstream sedimentation sources and restoration of the stream banks with natural materials between Lake Shore Drive and the lake to reduce erosion.

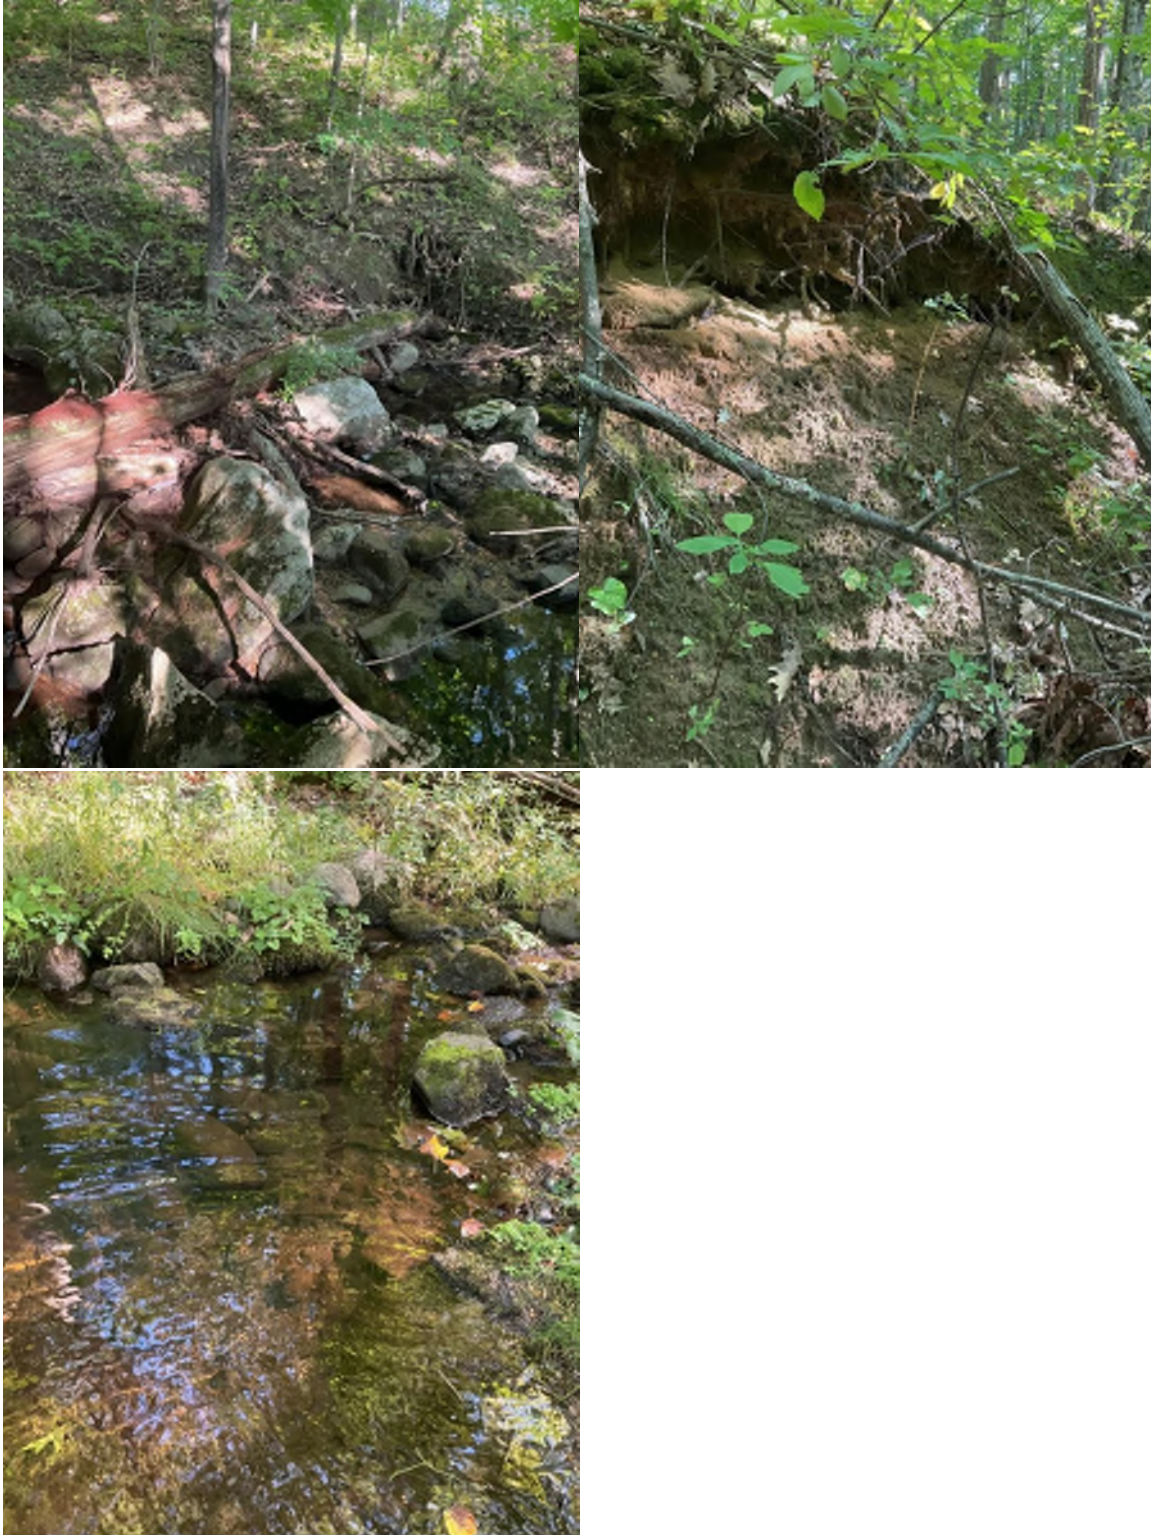
**Figure B-7**

**Erosion in the Vicinity of the Brook near Tabers at Lake Shore Drive, Auburn**

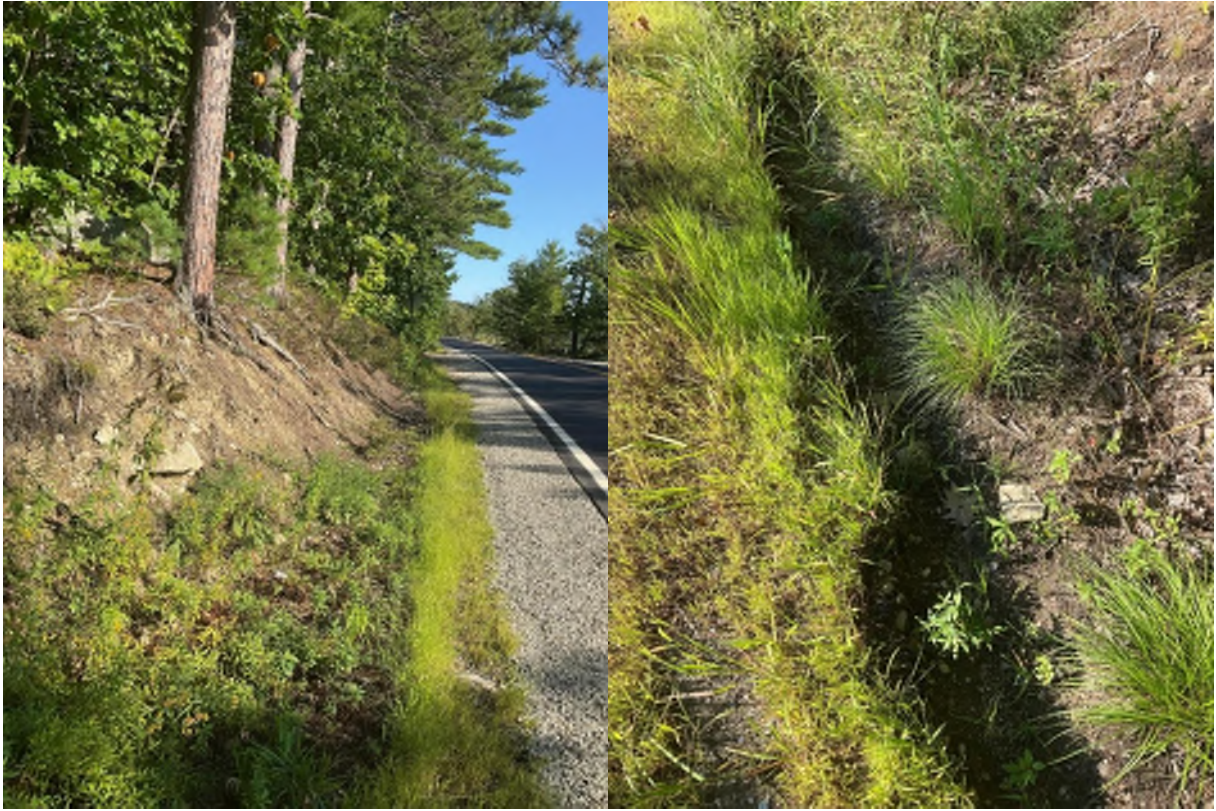
**Figure B-9**

Drainage on the inland side of Lake Shore Drive is conveyed by a ditch to several culverts. There are occasional areas of erosion from the steep slope inland from Lake Shore Drive into the ditch, with additional erosion evident within the ditch (**Figure B-9**). Armoring or stabilization (for instance, by hydroseeding) of steep slopes adjacent to Lake Shore Drive, and maintenance of ditches would reduce the potential for erosion and pollutant transport into the lake from Lake Shore Drive.

**Erosion on Inland Side of Lake Shore Drive (North)**

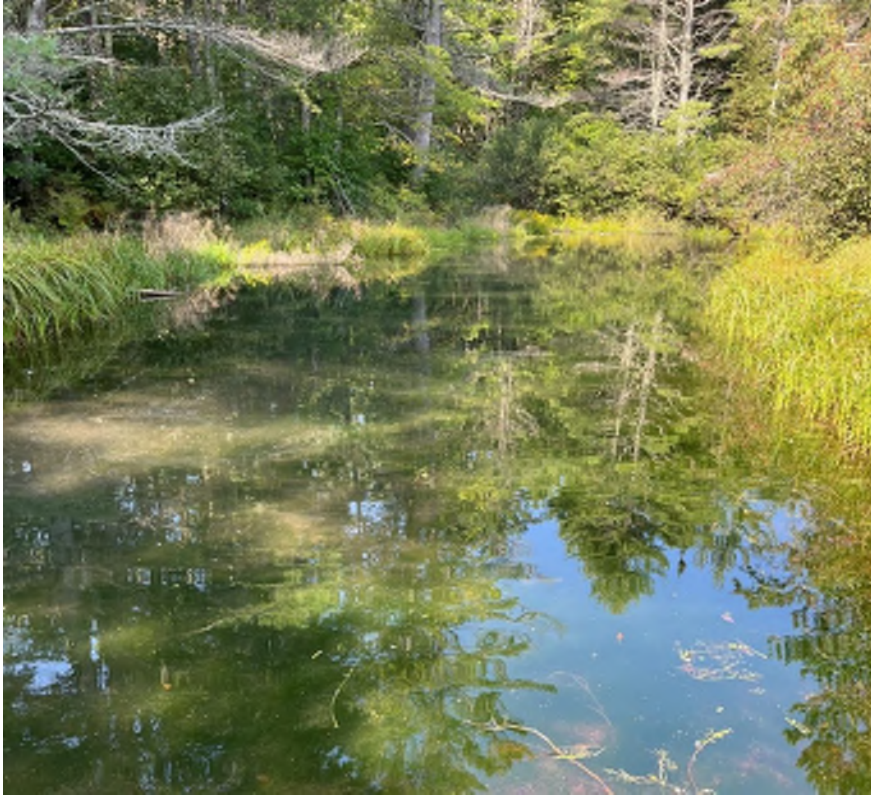
The Tot Lot property also contains an old fish hatchery, with the pond remaining. Visual inspection of the pond during the 2022 survey (**Figure B-15**) found high levels of algae, suggesting excess nutrients in the pond. The outlet structure of this pond drains to Townsend Brook. Additional investigations are warranted to determine if this pond is a significant source of excessive nutrient loading to the lake.

**Figure B-15**  
**Old Fish Hatchery Pond**  
**TB-6: Sand Pit**

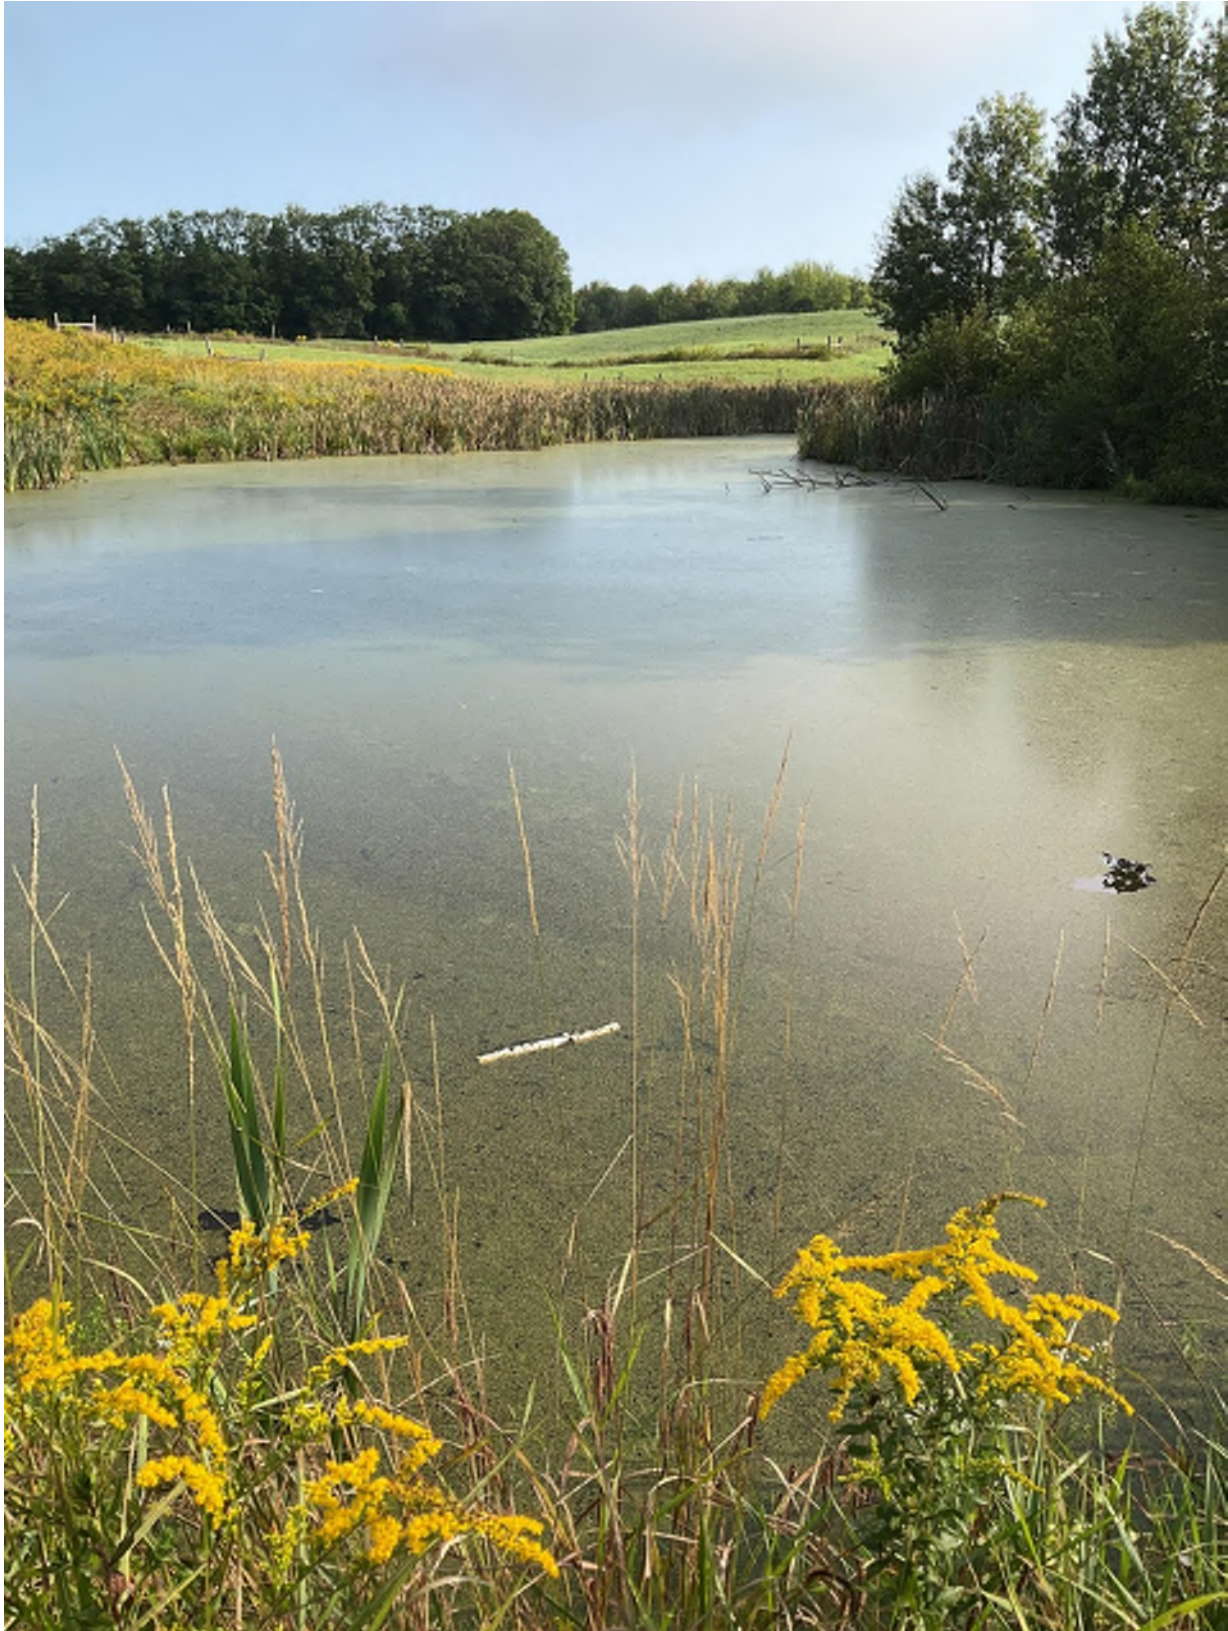
Blanchard's Pond, at the headwaters of First Brook, is located on a private farm, and appears to have excessive nutrient loading (**Figure B-16**). This pond is located downstream from tilled fields and livestock. AWD/LWD monitoring data indicate elevated nutrient concentrations at this location. The potential nutrient load from this pond is likely mitigated by a downstream wetland (**Figure B-17**), but still likely contributes nutrient load to Lake Auburn. This is supported by monitoring data that indicate an overall reduction in nutrient concentrations between the upstream extent to the outlet at the lake. A riparian buffer should be restored around Blanchard's pond. If elevated nutrient concentrations persist, pond remediation (alum or dredging) should be considered.

**Figure B-16**  
**Blanchard's Pond**

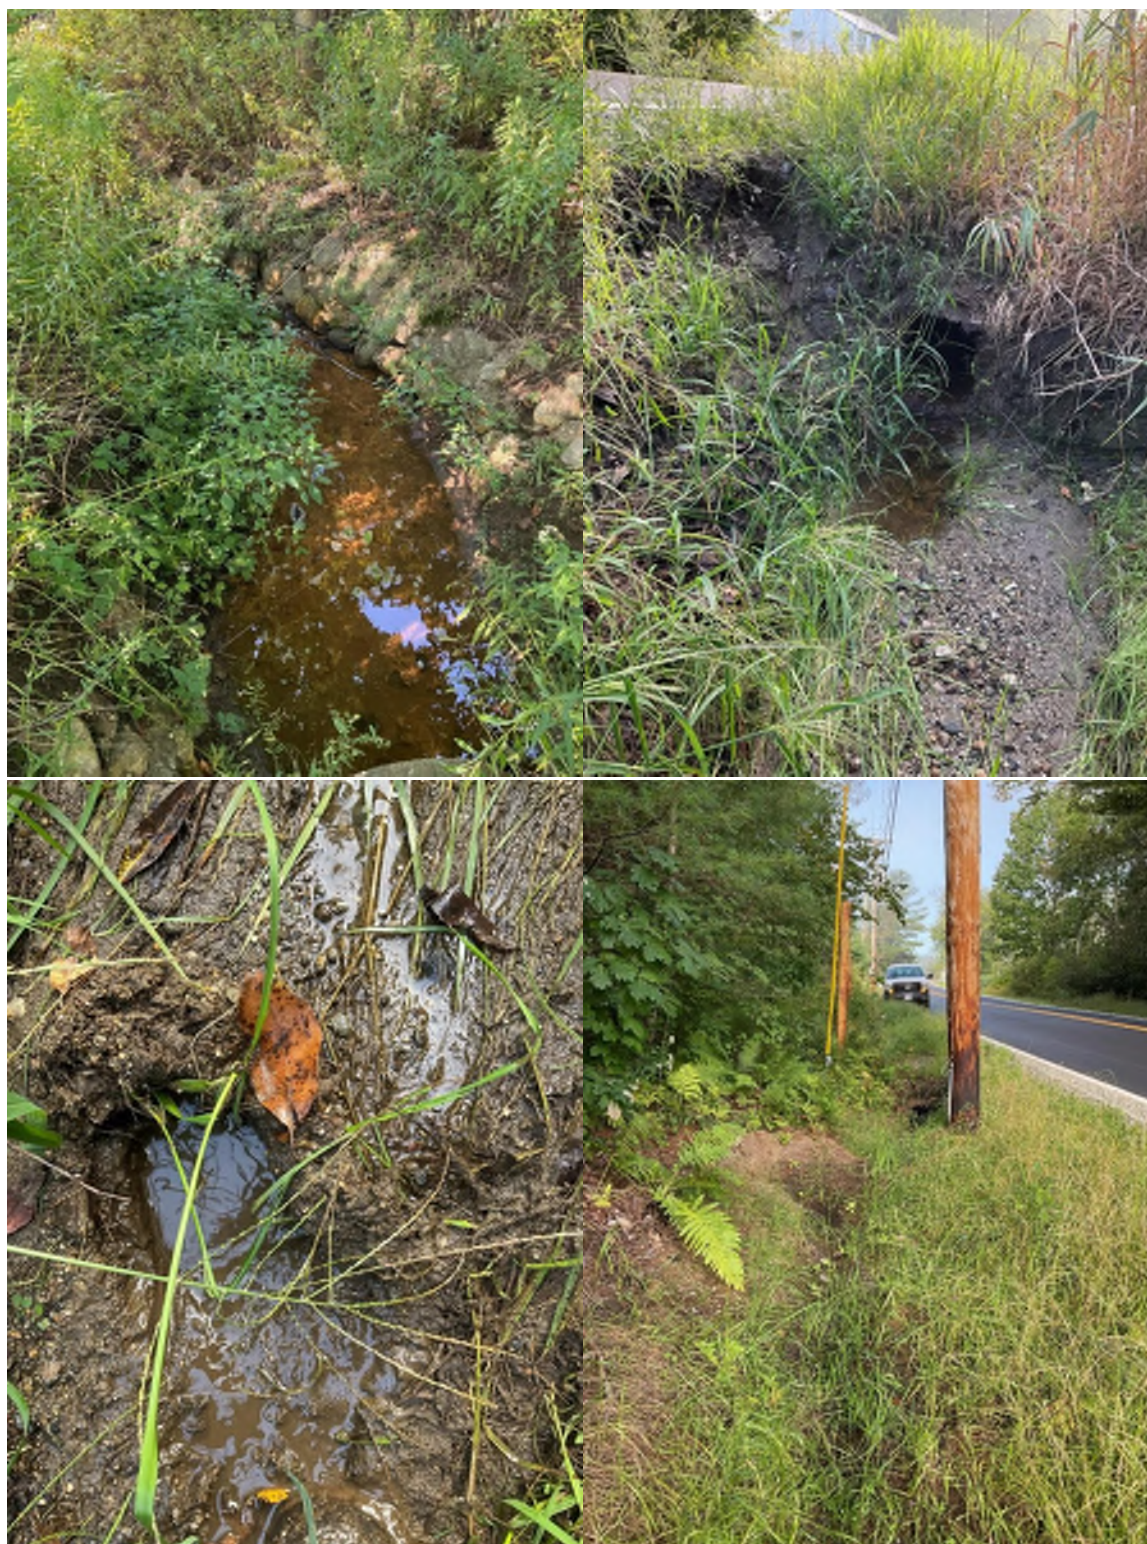
**Figure B-18**

First Brook downstream of Blanchard's Pond exhibits evidence of erosion and sediment transport. Examples include the culverts at Rt 4 (TB-8) and Lake Shore Drive (TB-9 and TB-10) (**Figure B-18**). Additional armoring of the stream, ditches on Lake Shore Drive, and culverts would help reduce this erosion and subsequent sediment transport to the lake.

**Examples of Erosion on First Brook**

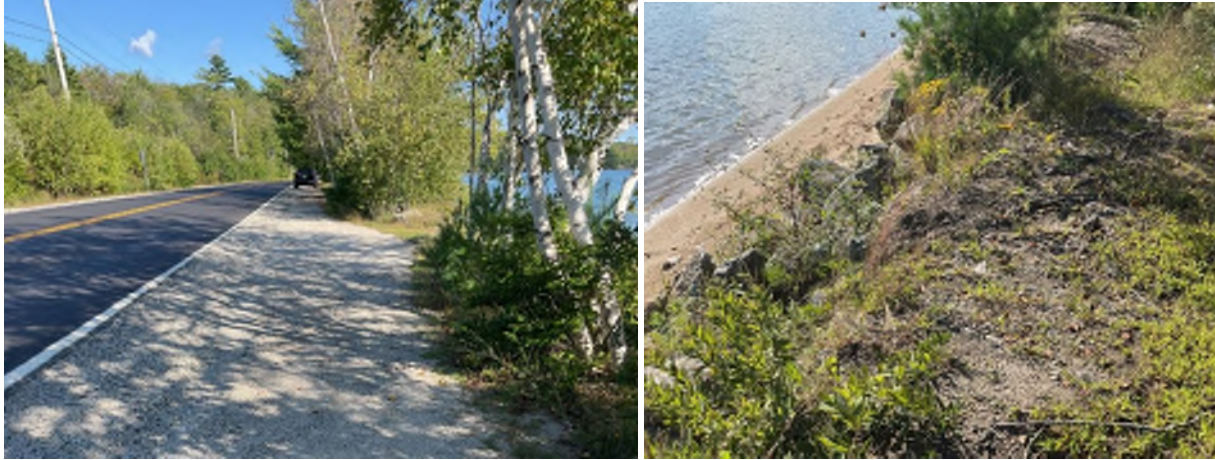
Lake Shore Drive has occasional gravel pull outs for parking (see example, **Figure B-20**). These are typically sloped towards the lake and show evidence of erosion. The potential erosion source could be reduced either prohibiting parking on the shoreline of the lake or by constructing paved, level surfaces (using permeable pavement to reduce runoff). Note that these pull-out parking areas also exist in places on the northern portion of Lake Shore Drive.

**Figure B-20**  
**Lake Shore Drive Parking (L) and Erosion Near Parking Ar®(R)**

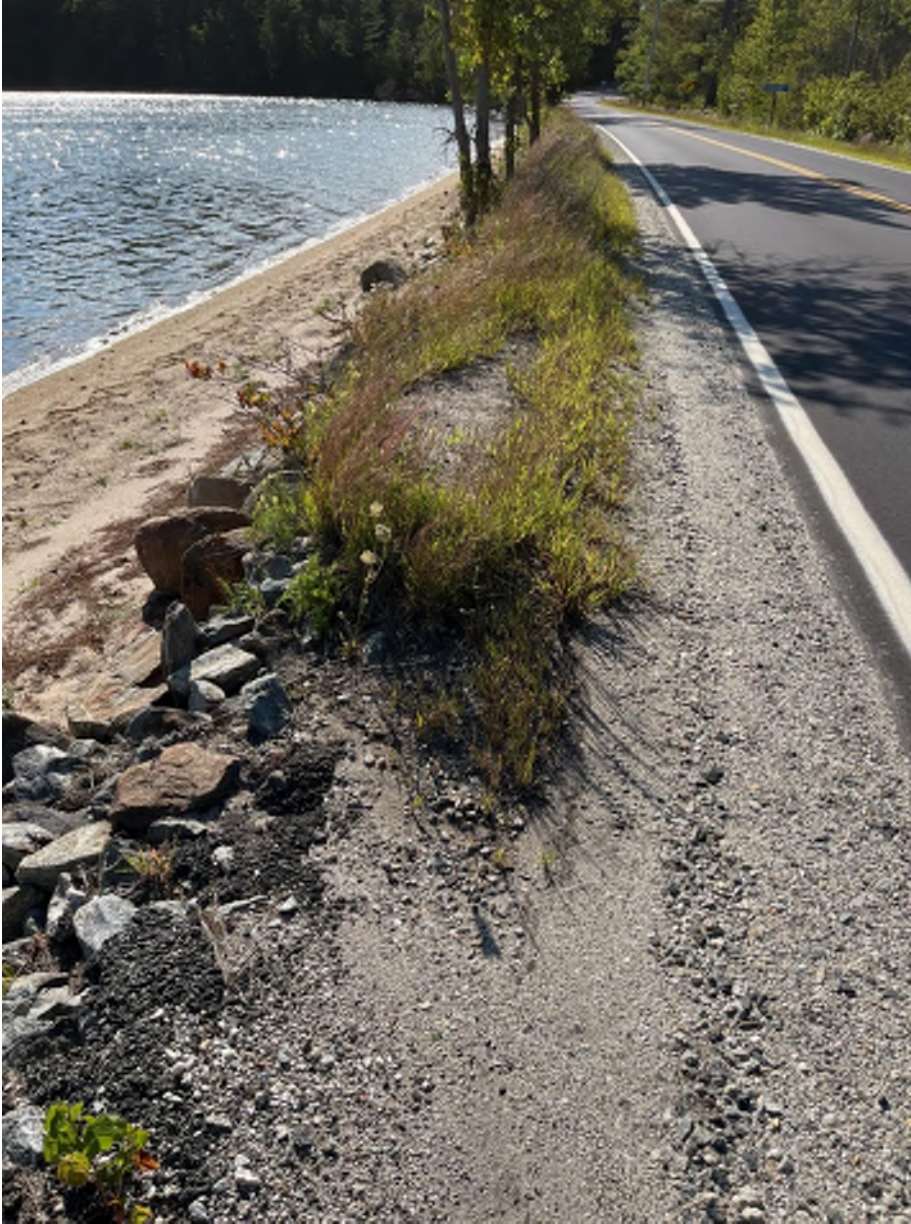
Erosion along the lake side of Lake Shore Drive is also a potential pollution source. As with the northern portion (LS-7 – LS-10), the shoreline of Lake Shore Drive is characterized by a narrow buffer between the lake and the road. While much of the road does have a thin vegetated filter strip, occasionally this buffer is not present (e.g., **Figure B-21**), causing significant erosion from the road into the lake (**Figure B-22**).

**Figure B-21**  
**Shoreline of Lake Shore Drive Showing Vegetated Filter Strip with Gap Causing Erosion to Reach the Lake**

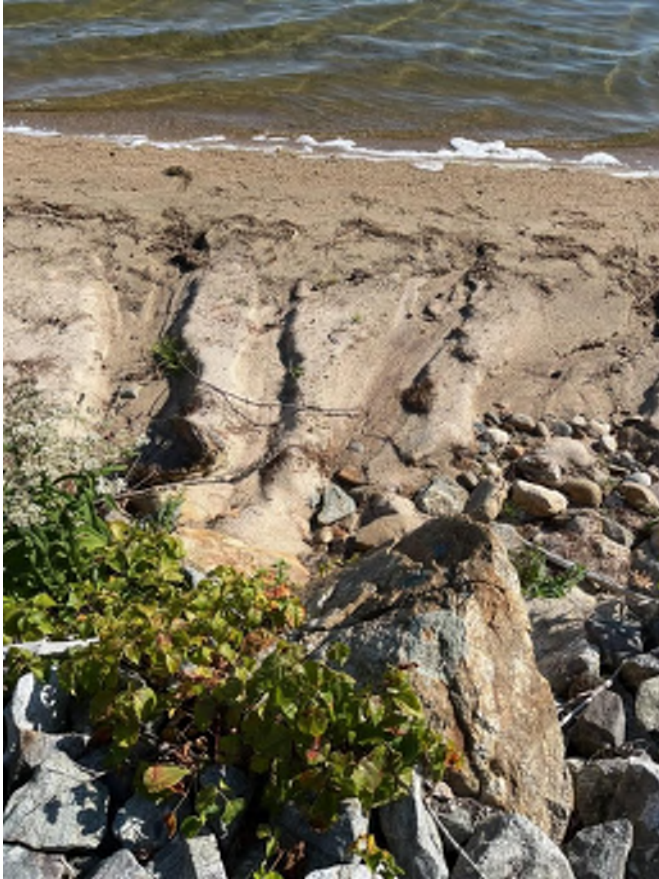
**Figure B-22**  
**Erosion from Lake Shore Drive**

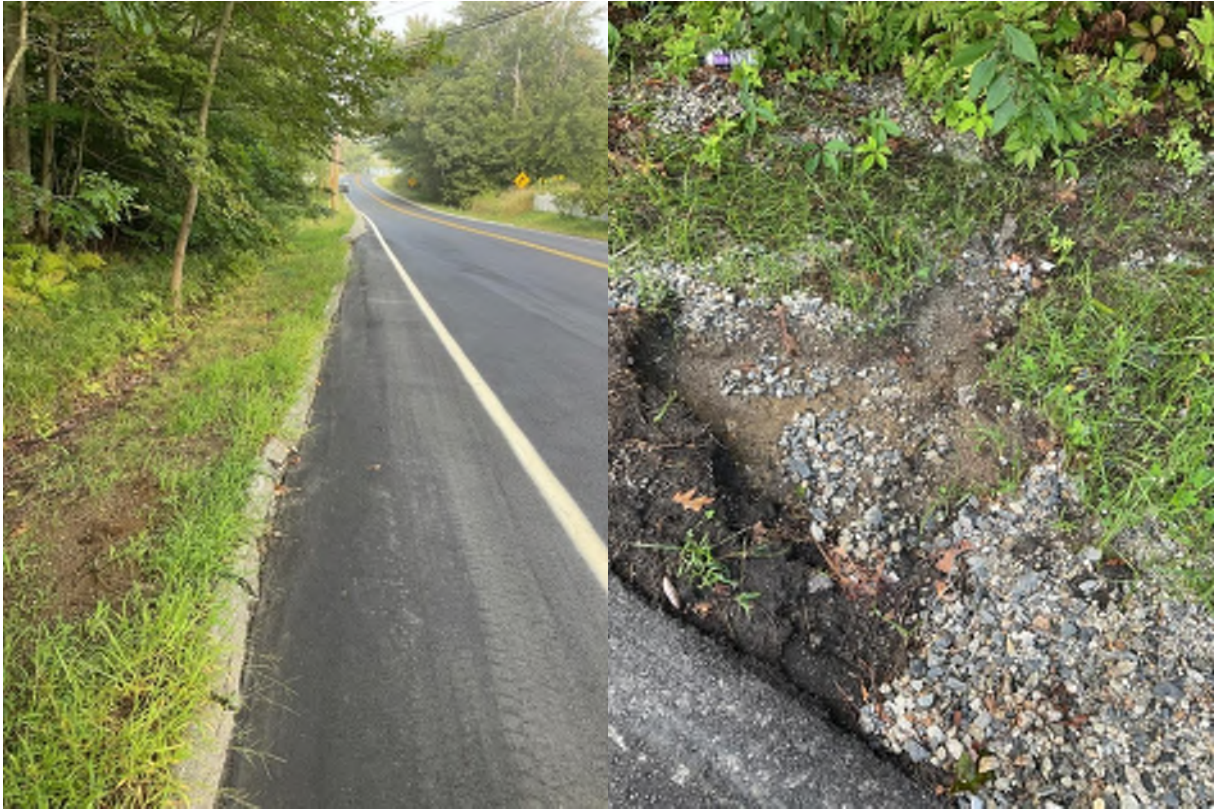
MaineDOT recently updated drainage near the intersection of Lake Shore Drive and Route 4, including armoring/vegetating ditches. However, the ditch on the lake side of Lake Shore Drive in this area (TB-12) is not adequately vegetated, and erosion is occurring from the road onto the shoulder, and then into the lake (**Figure B-23**).

**Figure B-23**  
**Erosion on the Lake Side of Lake Shore Drive at the Route 4 Intersection**

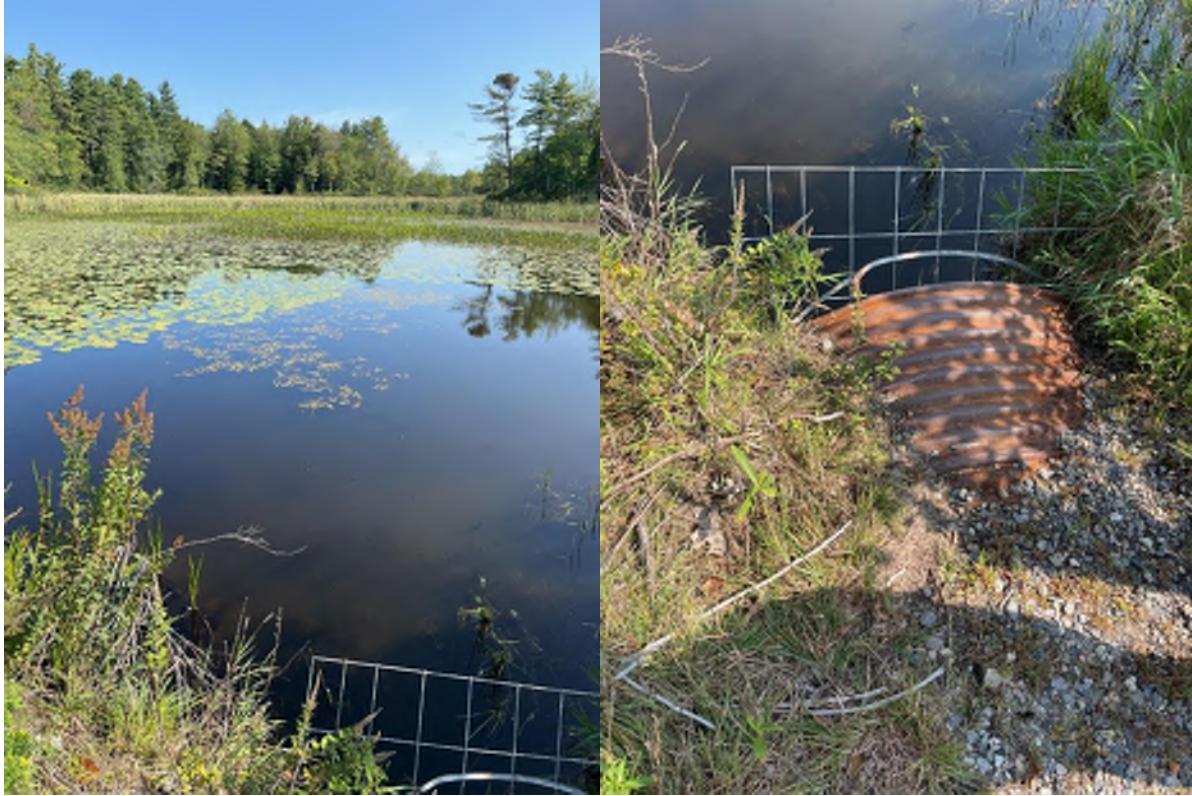
Townsend Brook ends at a large pond/wetland on the north side of Lake Shore Drive, and then passes through a culvert before discharging to Lake Auburn. The pond appears productive, with significant emergent vegetation and turbid water (**Figure B-24**); AWD/LWD staff reported that algal blooms are not typically observed. The pond occasionally overtops Lake Shore Drive (once every few years), although more frequent overtopping occurs at a low spot on Lake Shore Drive to the west of Townsend Brook. Occasional beaver activity occurs that causes the culvert to become clogged. AWD/LWD has installed a grate to discourage beaver activity, and works with USDA if necessary to address beaver activity.

**Figure B-24**  
**Townsend Brook Outlet at Pond (North of Lake Shore Drive)**

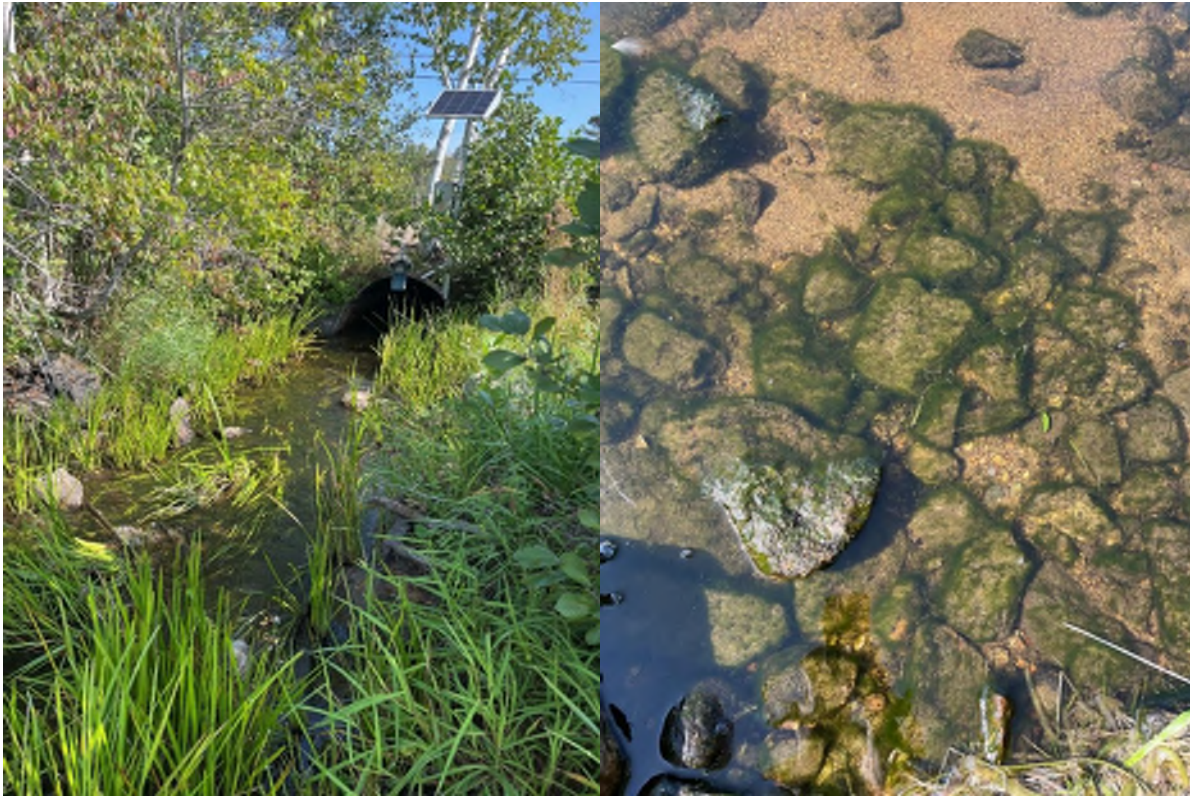
Downstream of the culvert, no sediment deltas or other indications of significant sediment transport or erosion were observed. However, moderate emergent vegetation and periphyton accumulation occurs on rocks located in the outlet channel prior to discharge into Lake Auburn. This accumulation of periphyton does not appear to continue into the lake (**Figure B-25**). The culvert is in adequate condition with no evidence of erosion near neither the inlet or outlet.

**Figure B-25**  
**Townsend Brook Downstream of Lake Shore Drive Culvert**

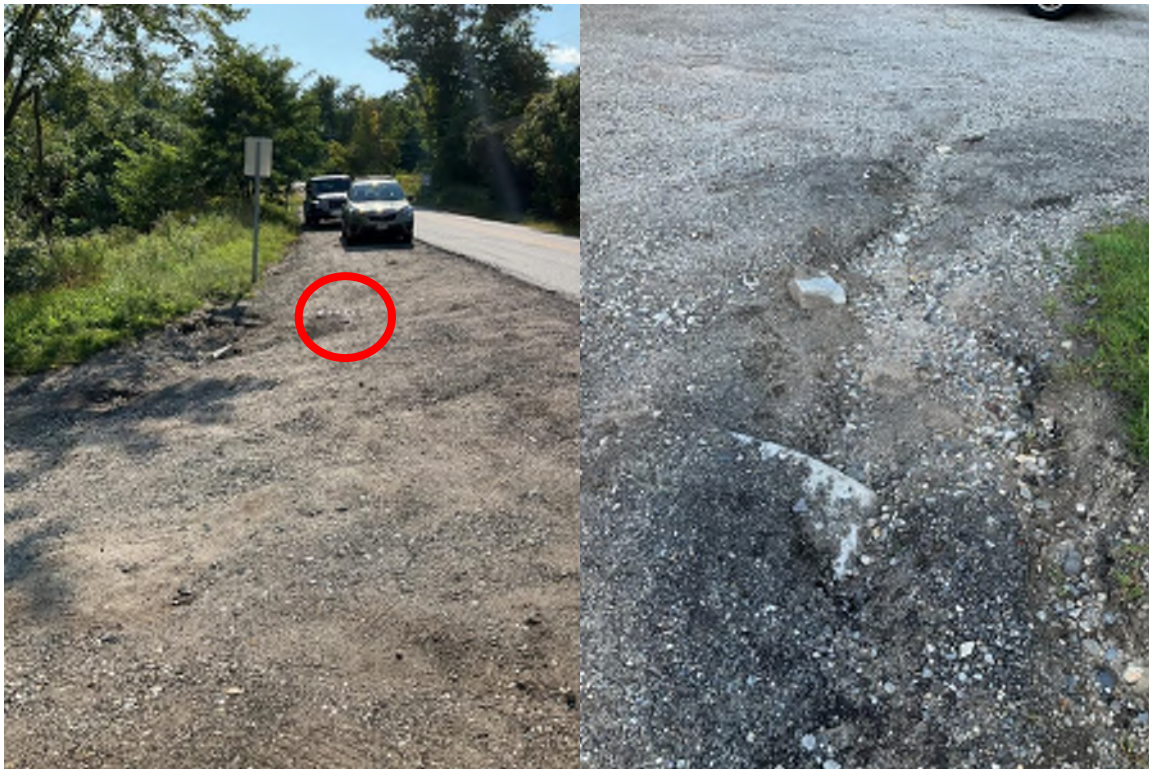
The parking area located at the northern terminus of the closed section of Whitman Spring Road on N. Auburn Road (at the intersection of Whitman Spring Road) has evidence of significant erosion from stormwater flowing down the steep slope of N. Auburn Road towards Lake Auburn (**Figure B-27**). A catch basin was installed at this location to divert flow into a culvert that then flows into Lake Auburn. The catch basin inlet is not oriented correctly to the direction of flow (it is pointing towards N. Auburn Road and not in the direction of the slope), and the significant erosion in the dirt parking area indicates that most flow currently bypasses the catch basin, flows down Whitman Spring Road, and into the stream to Lake Auburn. The culvert that the catch basin discharges to is newly installed with a significant, armored plunge pool that reduces sediment transport from the parking area to Lake Auburn (noting that most of the flow is currently bypassing this culvert).

**Figure B-27**  
Eroding Parking Area and Catch Basin at Northern Whitman Spring Road Parking Area

Improvements at this location could include leveling and paving the parking area (either with asphalt or pavers), regrading the parking area such that the catch basin works properly, ensuring that the catch basin inlet is properly aligned to the main direction of flow, and potentially adding a filter strip to further treat runoff from N. Auburn Road.

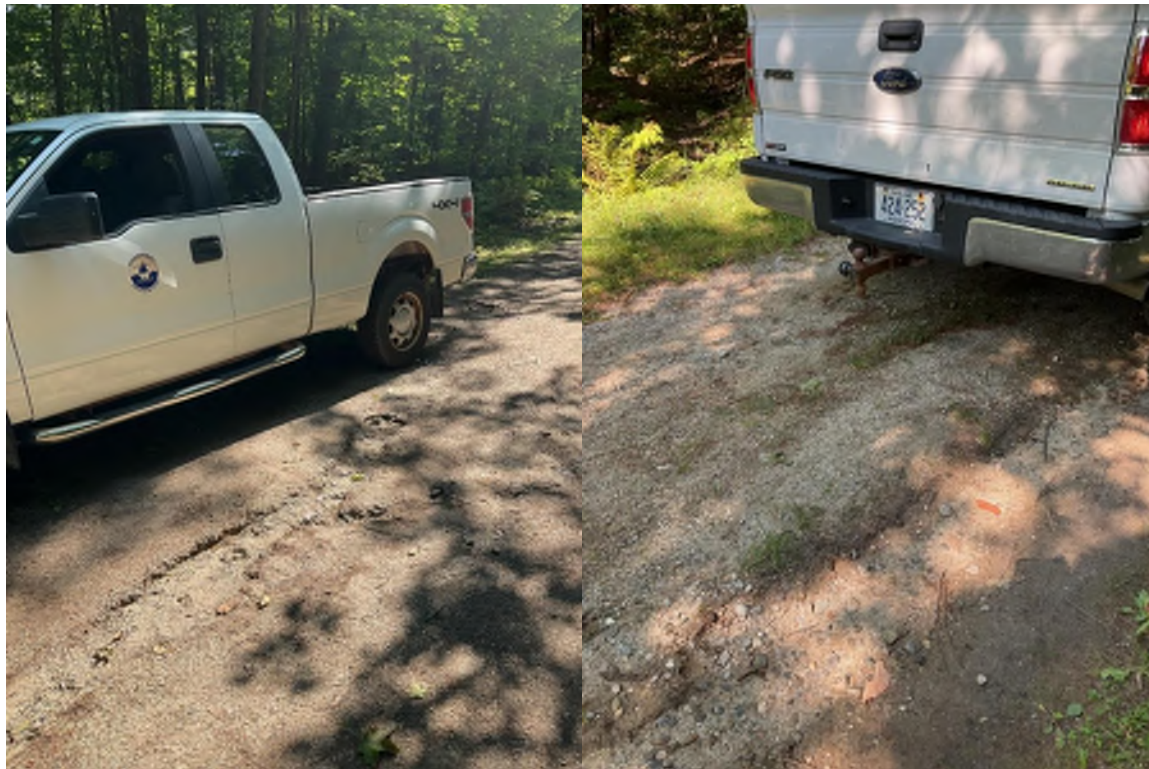
Two locations on Whitman Spring Road exhibit evidence of erosion on the road surface. These locations are both on steep sections of the road where water runs directly down the road, causing rills to develop and sediment to be transported from the road, across the culvert inlet and outlet embankments, and into Lake Auburn (examples in **Figure B-28**). At SR-4, the runoff from the road is bypassing the ditch/culvert, and is eroding the culvert outlet embankment (**Figure B-29**).

**Figure B-28**  
Erosion on Surface of Whitman Spring Road

This portion of the road should be regraded, and either crowned properly to prevent runoff from concentrating on the road surface or waterbars added to divert water from the road surface to the ditch on the side of the road.

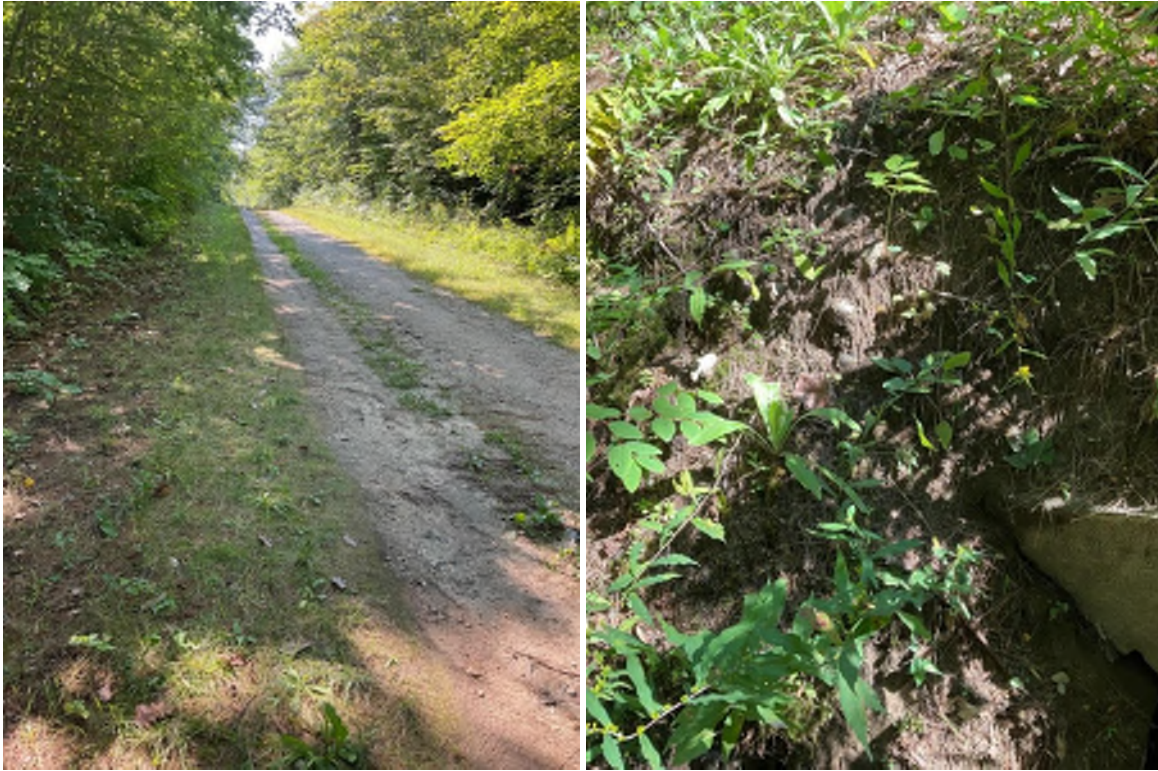
**Figure B-29**  
Slope at SR-4 and Erosion on Culvert Outlet Embankment

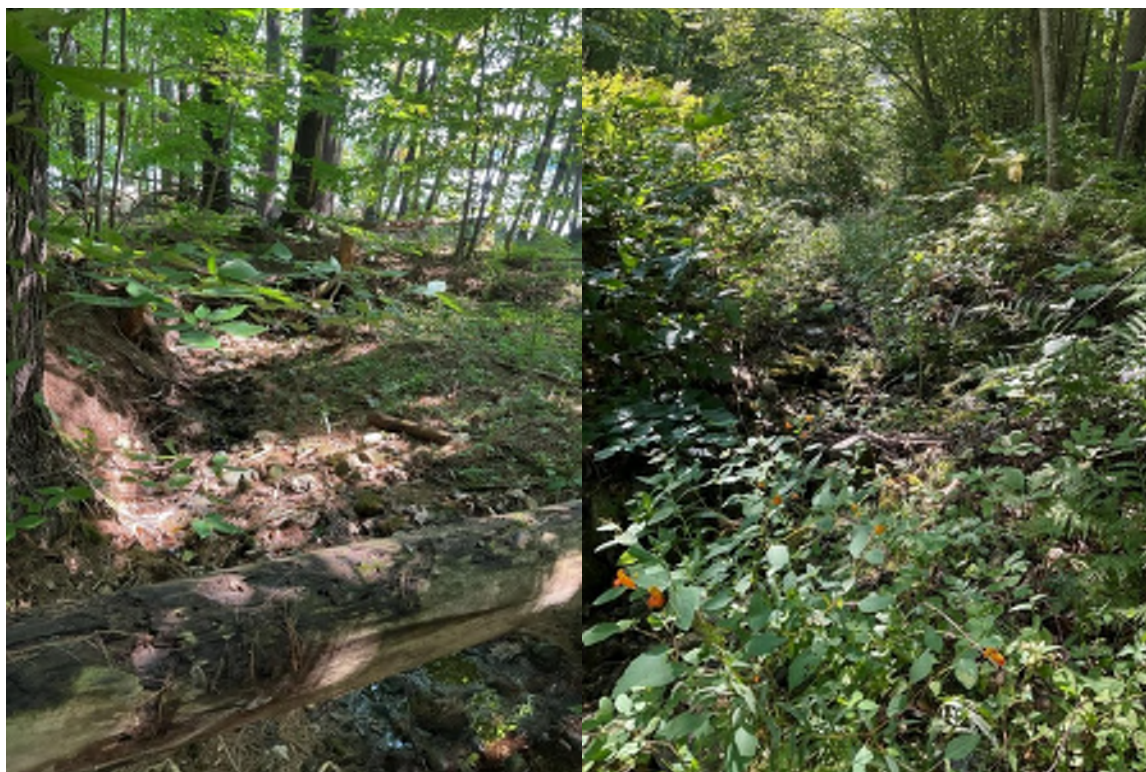
The culvert at SR-3 shows evidence of erosion in the channel downstream (left side, **Figure B-30**) of the culvert crossing (newly installed double barrel). The channel upstream of the culvert crossing (right side, **Figure B-30**) is well-armored with no evidence of erosion. In addition, the embankment on the outlet side at this culvert is significantly eroded (**Figure B-31**).

**Figure B-30**  
**New Culvert at location SR-3 with Evidence of Significant Downstream Erosion (L) but Well Armored Upstream (R)**

The outlet embankment should be armored with a plunge pool to reduce this source of erosion and the downstream channel stabilized (if necessary after armoring and adding a plunge pool).

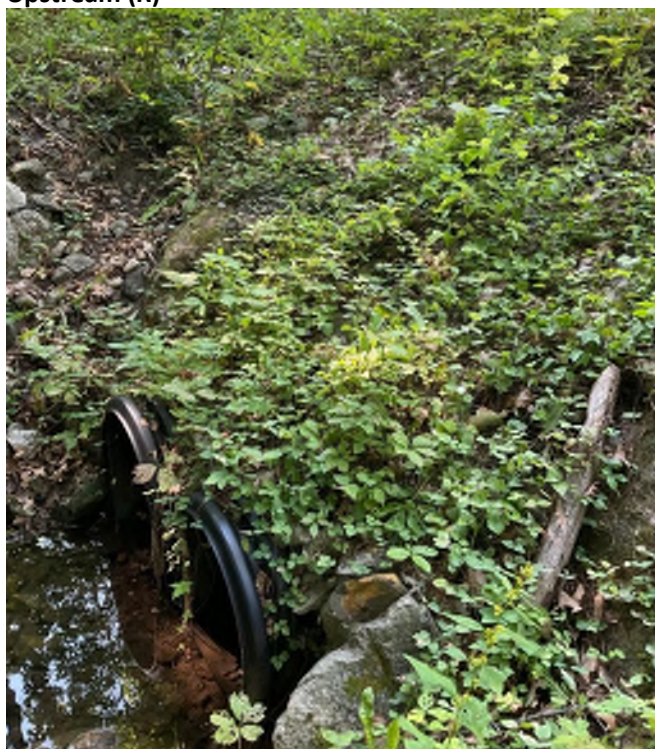
**Figure B-31**  
**Culvert at SR-3 with Significant Embankment Erosion**

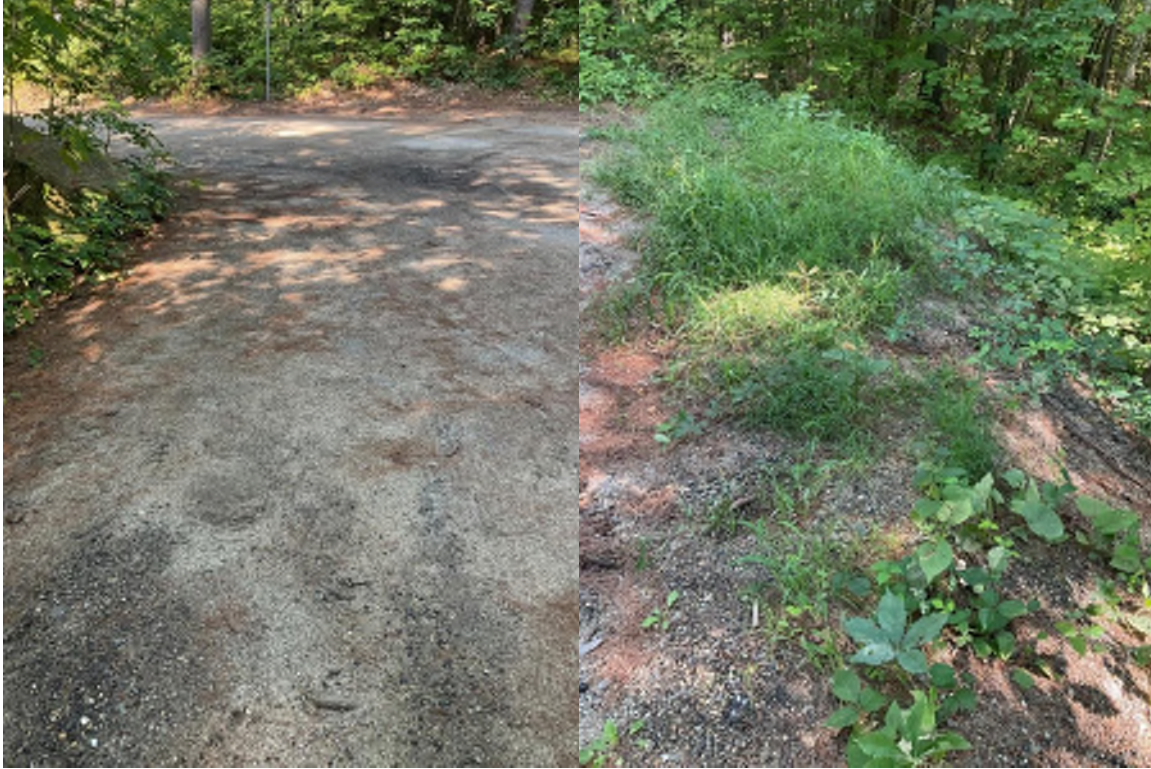
The southern parking area at Whitman Spring Road was previously paved, but the paving is mostly failed and the surface is mostly dirt. This parking area is sloped away from the road and is eroding (**Figure B-33**). This area could be leveled and repaved to reduce erosion potential.

**Figure B-33**  
South Parking Area
