# Lake Auburn Lake Watershed-based Protection Plan

## REPORT

August 2023 (Final)

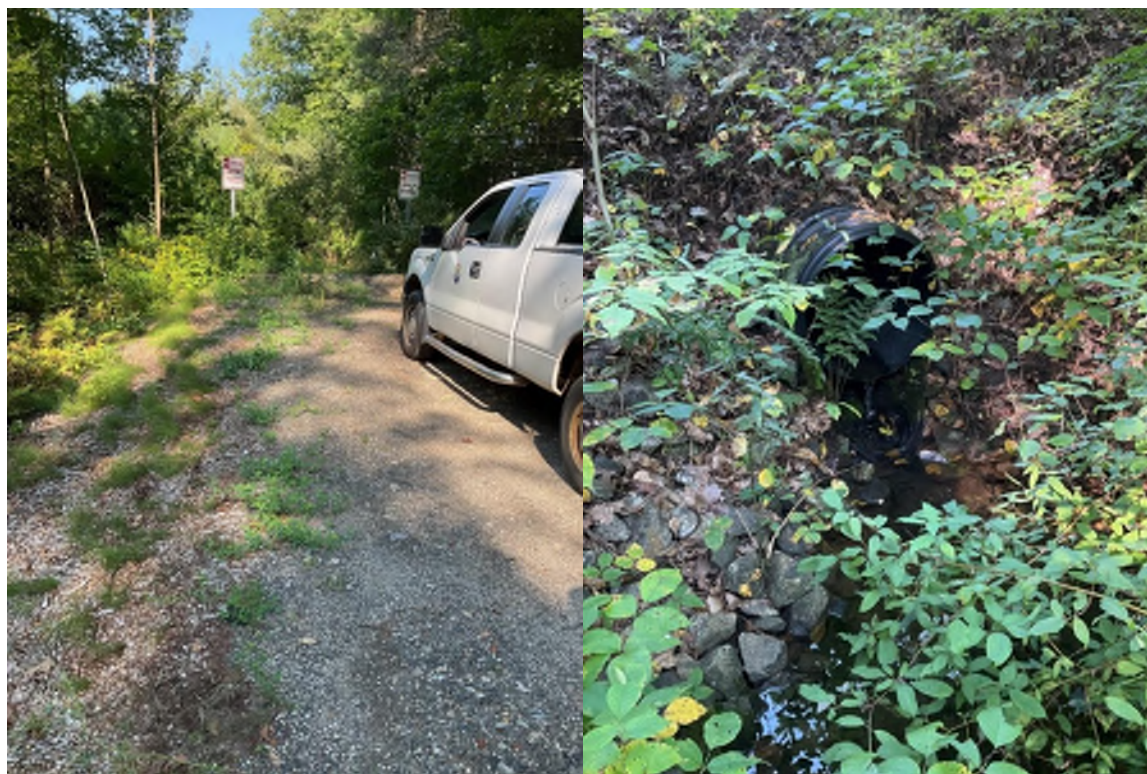
The City of Auburn maintains a snowplow turnaround on Whitman Spring Road (**Figure B-34**). This turnaround is unpaved and is eroding into the adjacent stream and ditch, which passes through a culvert and discharges to Lake Auburn. Additional erosion is occurring upstream and downstream of the culvert. Upstream, runoff from the turnaround discharges down a steep slope into the stream, and the unarmored inlet embankment is eroding into the stream, causing significant sediment buildup upstream of the culvert. On the downstream side, there is no ditch on the road, causing erosion from the road into the stream in addition to erosion over the outlet embankment. The culvert has a plunge pool to control sediment transport.

**Figure B-34**  
Erosion from Snowplow Turnaround (L) and Erosion at Culvert Outlet (R)

The snowplow turnaround could be paved, with the culvert armored upstream and downstream. The embankment between the snowplow turnaround and the stream should be armored or stabilized to prevent erosion.

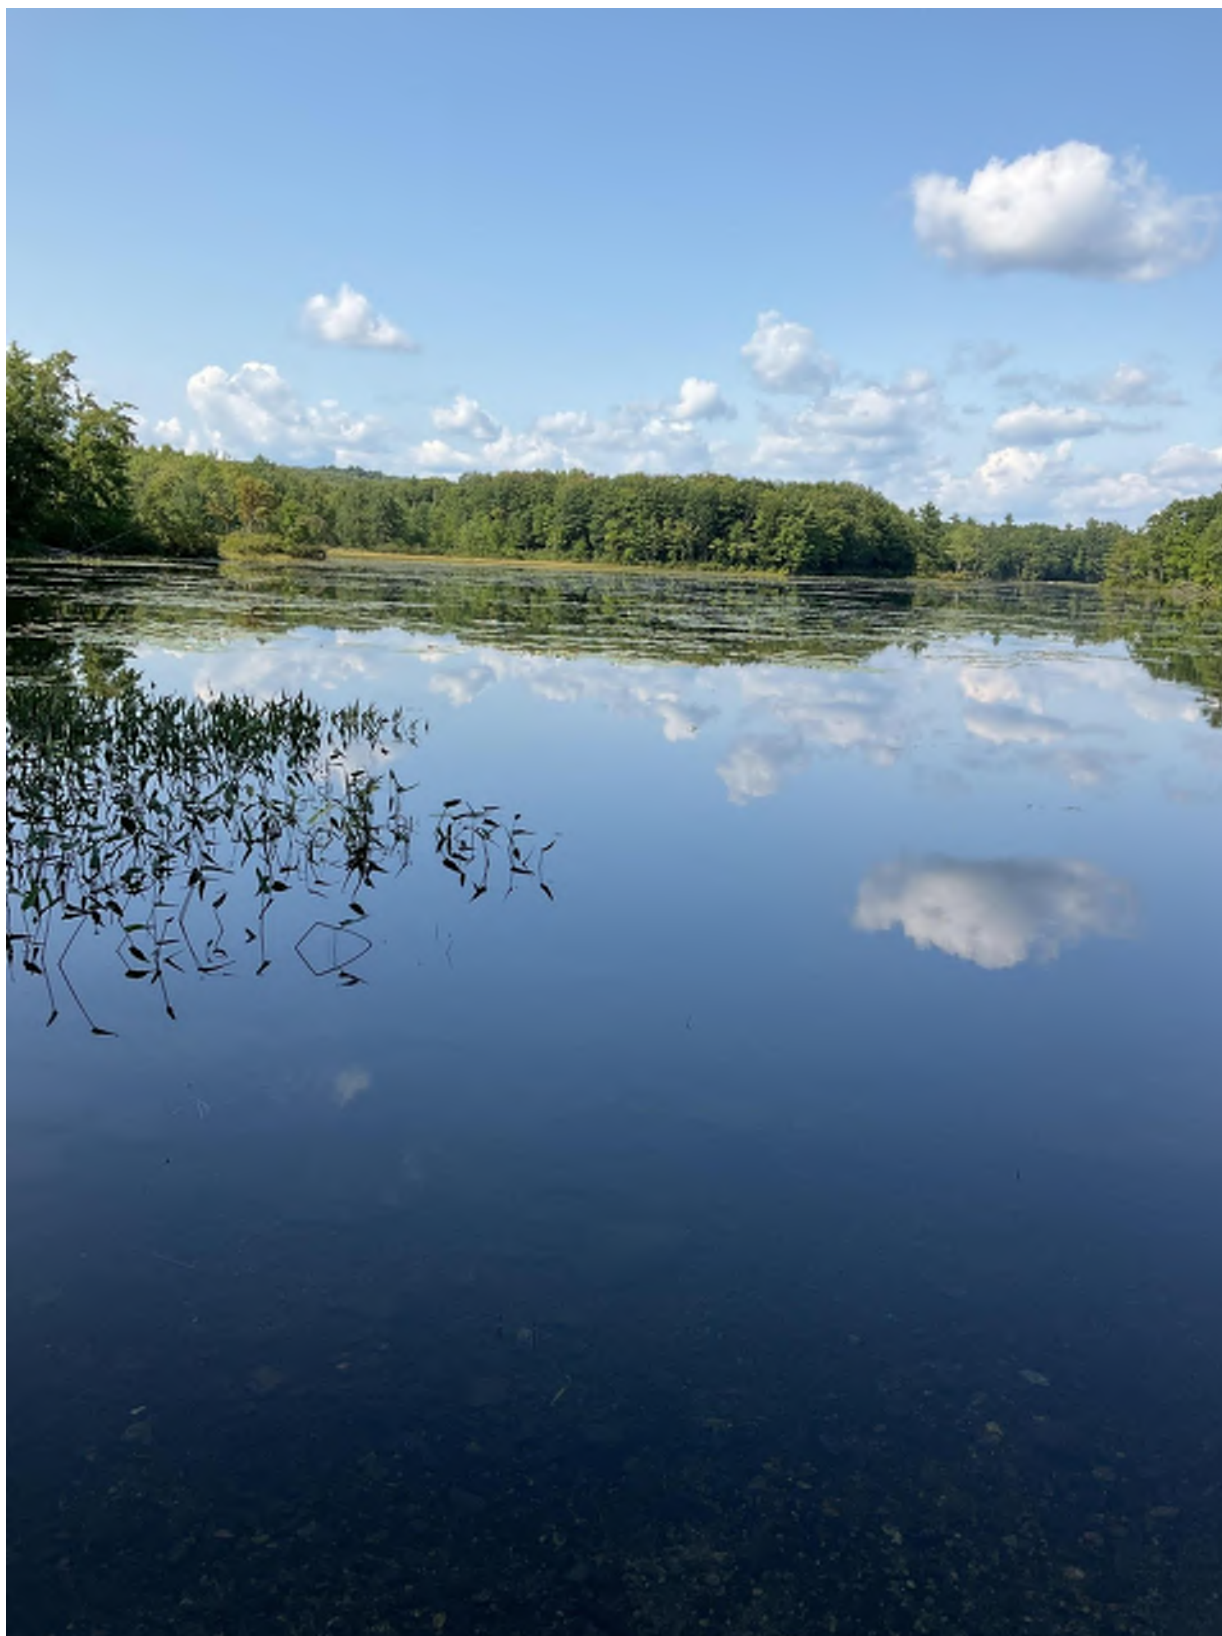
While the pond appears to have a moderate amount of emergent vegetation including milfoil, algal blooms have not been observed in the pond (**Figure B-37**).

**Figure B-37**  
**The Basin**

The extent of sediment deposition within the lower portion of the Basin should be evaluated, and if necessary, dredging should be considered to restore the sediment retention capacity of the Basin. Milfoil should be removed and potentially replaced with native vegetation. In addition, this location could be a potential area for an alum feed system.

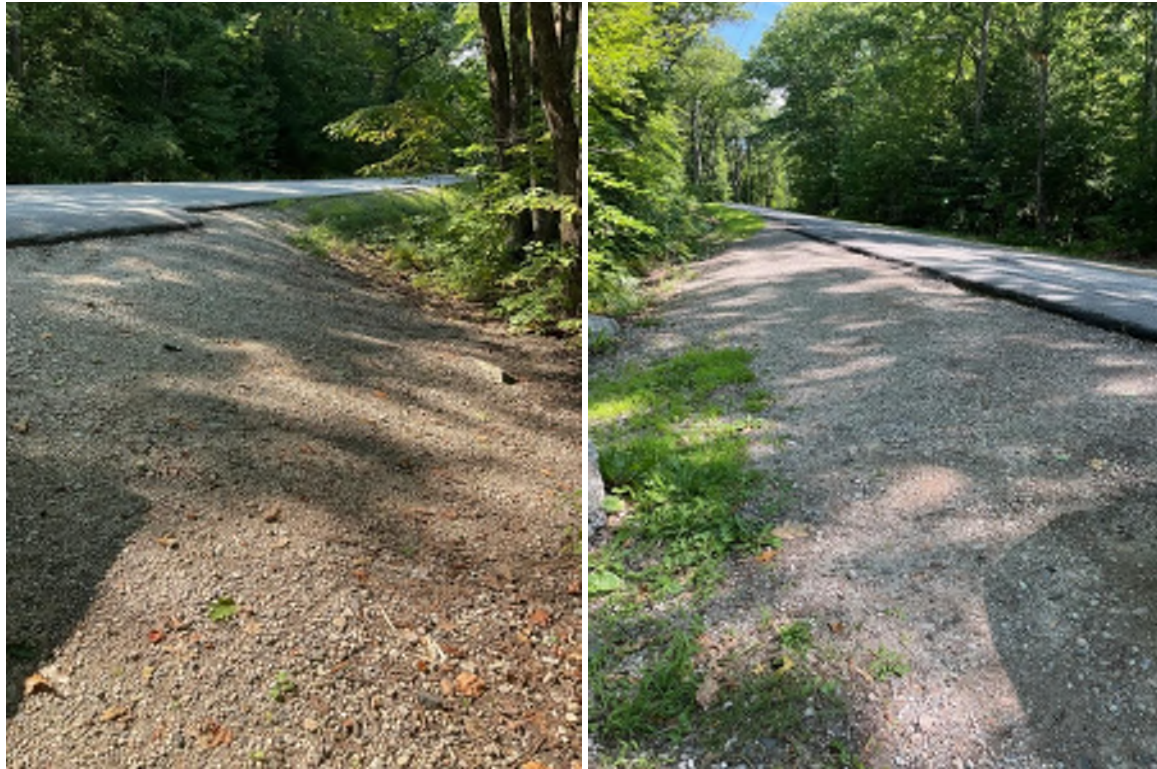
There are several turnouts on Holbrook Road adjacent to the Basin for parking and access to the Basin. These are unpaved, slope towards the pond, and show evidence of erosion (**Figure B-38**). If these remain as parking areas for visitors to the Basin, these should be leveled and hardened (either paved or with pavers) to prevent future erosion.

**Figure B-38**  
**Erosion at Gravel Parking Areas on Holbrook Road near the Basin**

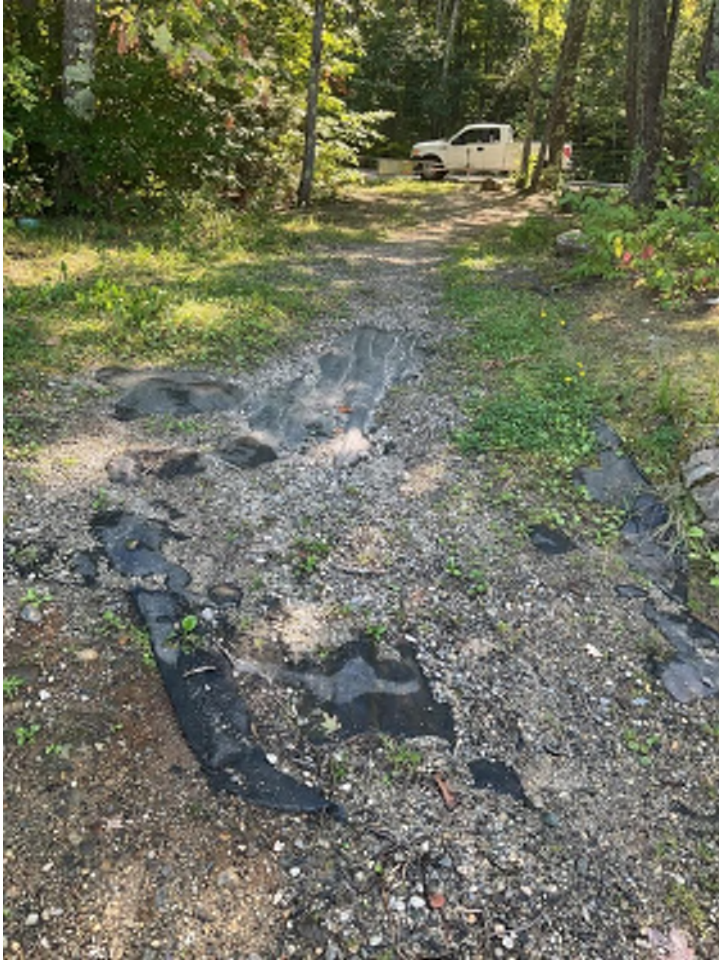
Adjacent to each parking area are access points to the Basin. These show evidence of erosion, with one location (UB-4) eroded to expose geotextile fabric (**Figure B-39**). This location should be restored to prevent future erosion.

**Figure B-39**  
Erosion at The Basin Access Point Near UB-4

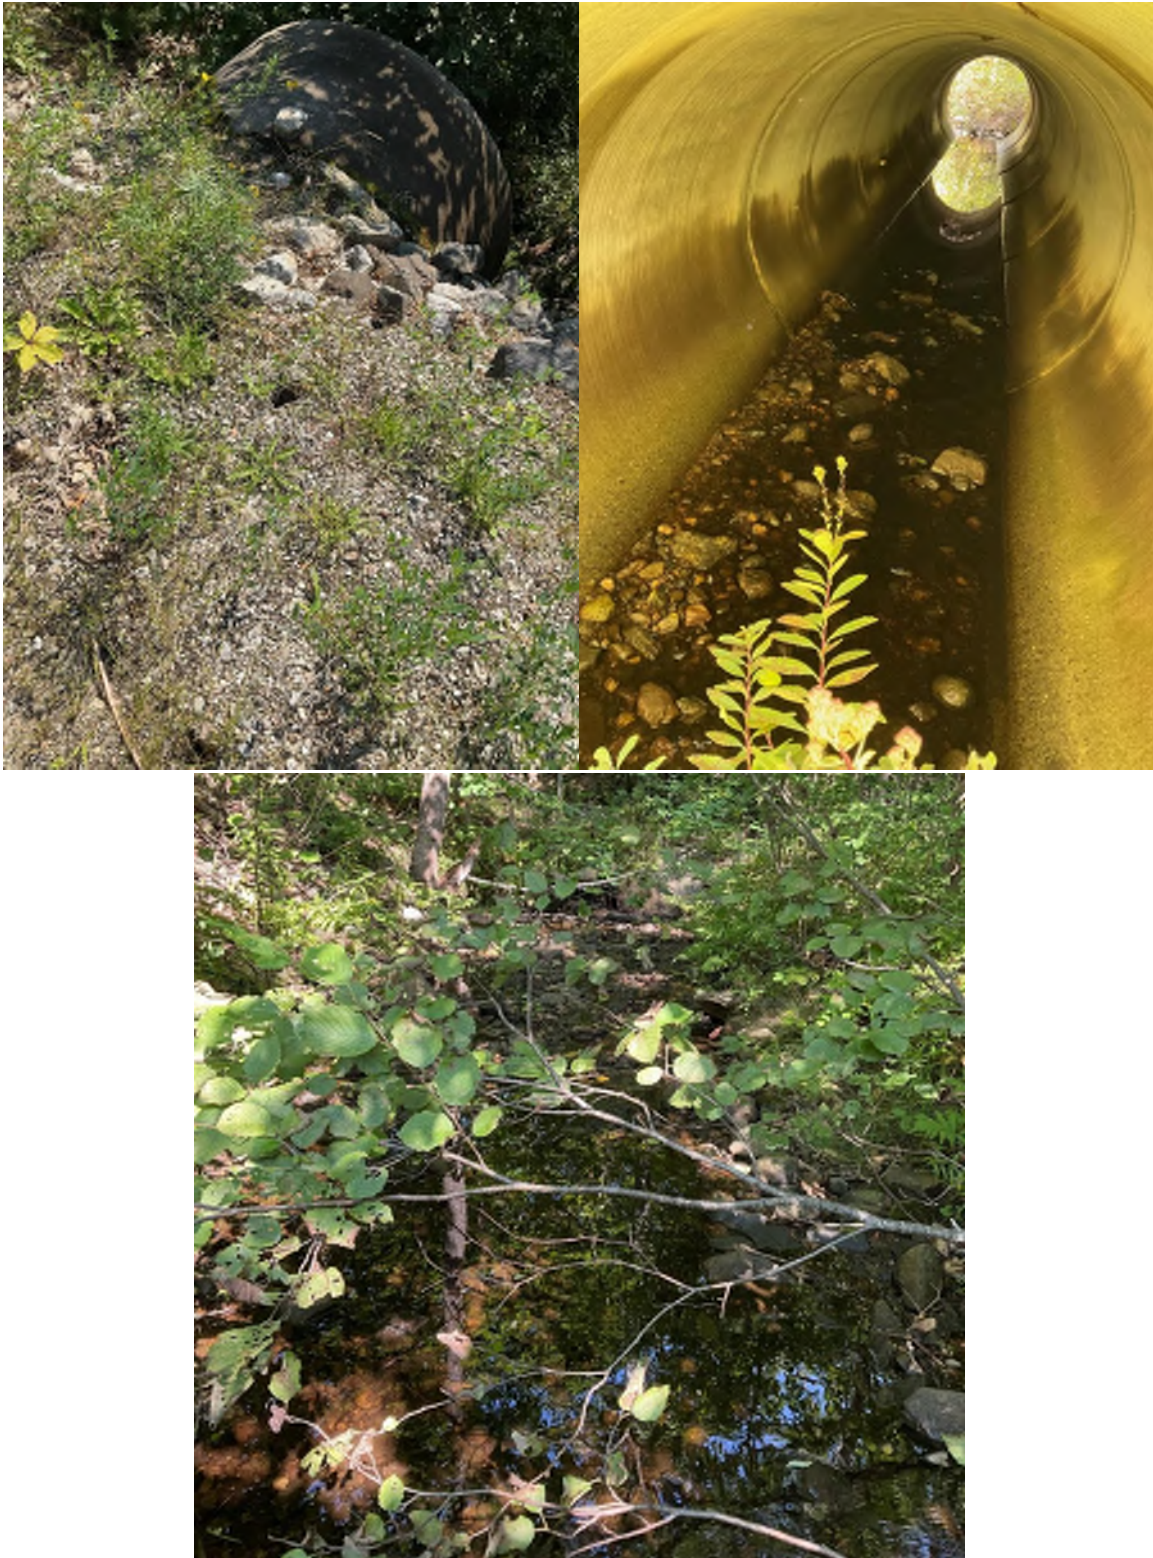
**Figure B-43**

**Holbrook Road Culvert**

*Clockwise from top left: minor erosion on outlet embankment; no evidence of sediment transport within culvert; no evidence of sediment accumulation downstream*

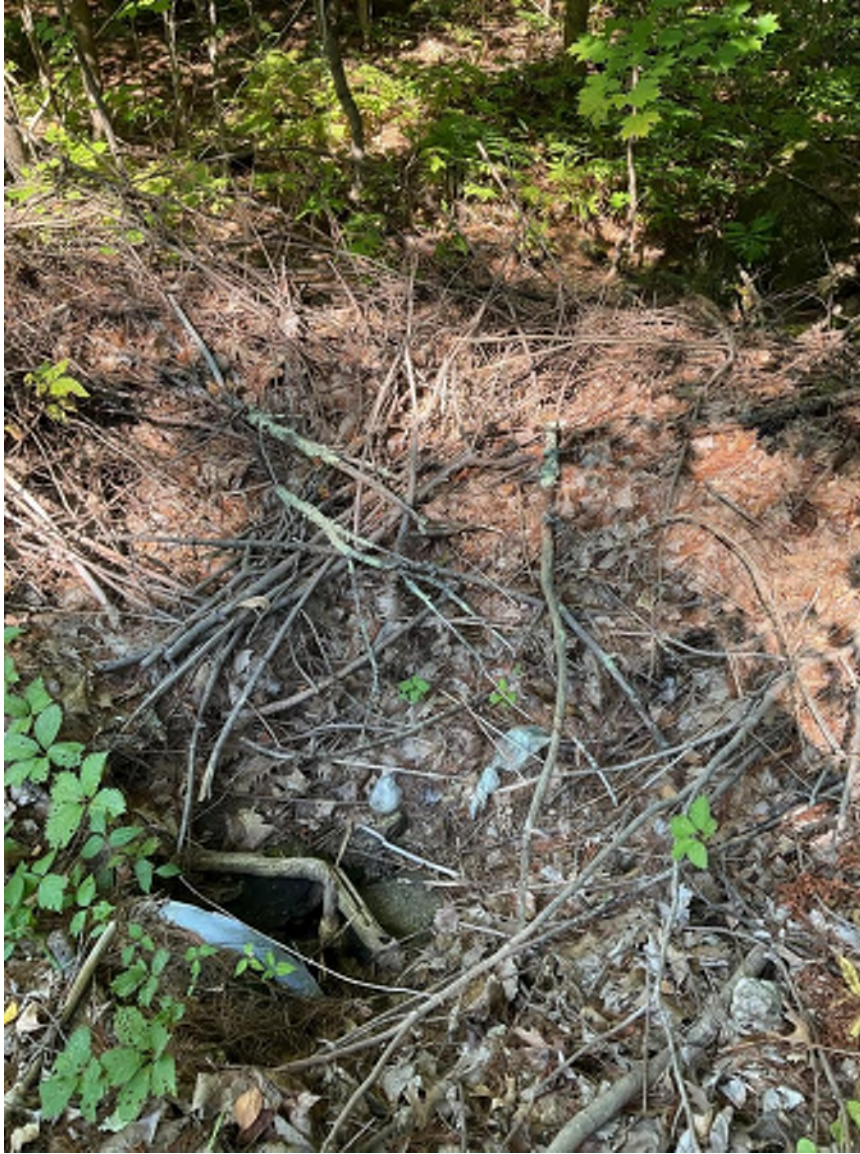
The culvert at UB-8 is located on Hersey Hill Rd, and exhibits evidence of moderate erosion on the upstream side of the culvert. A plunge pool exists on the downstream end, but it is clogged with sediment and debris. The ditch at this location should be revegetated, and the plunge pool cleaned.

**Figure B-44**  
**Plunge Pool at Hersey Hill Rd (UB-8)**

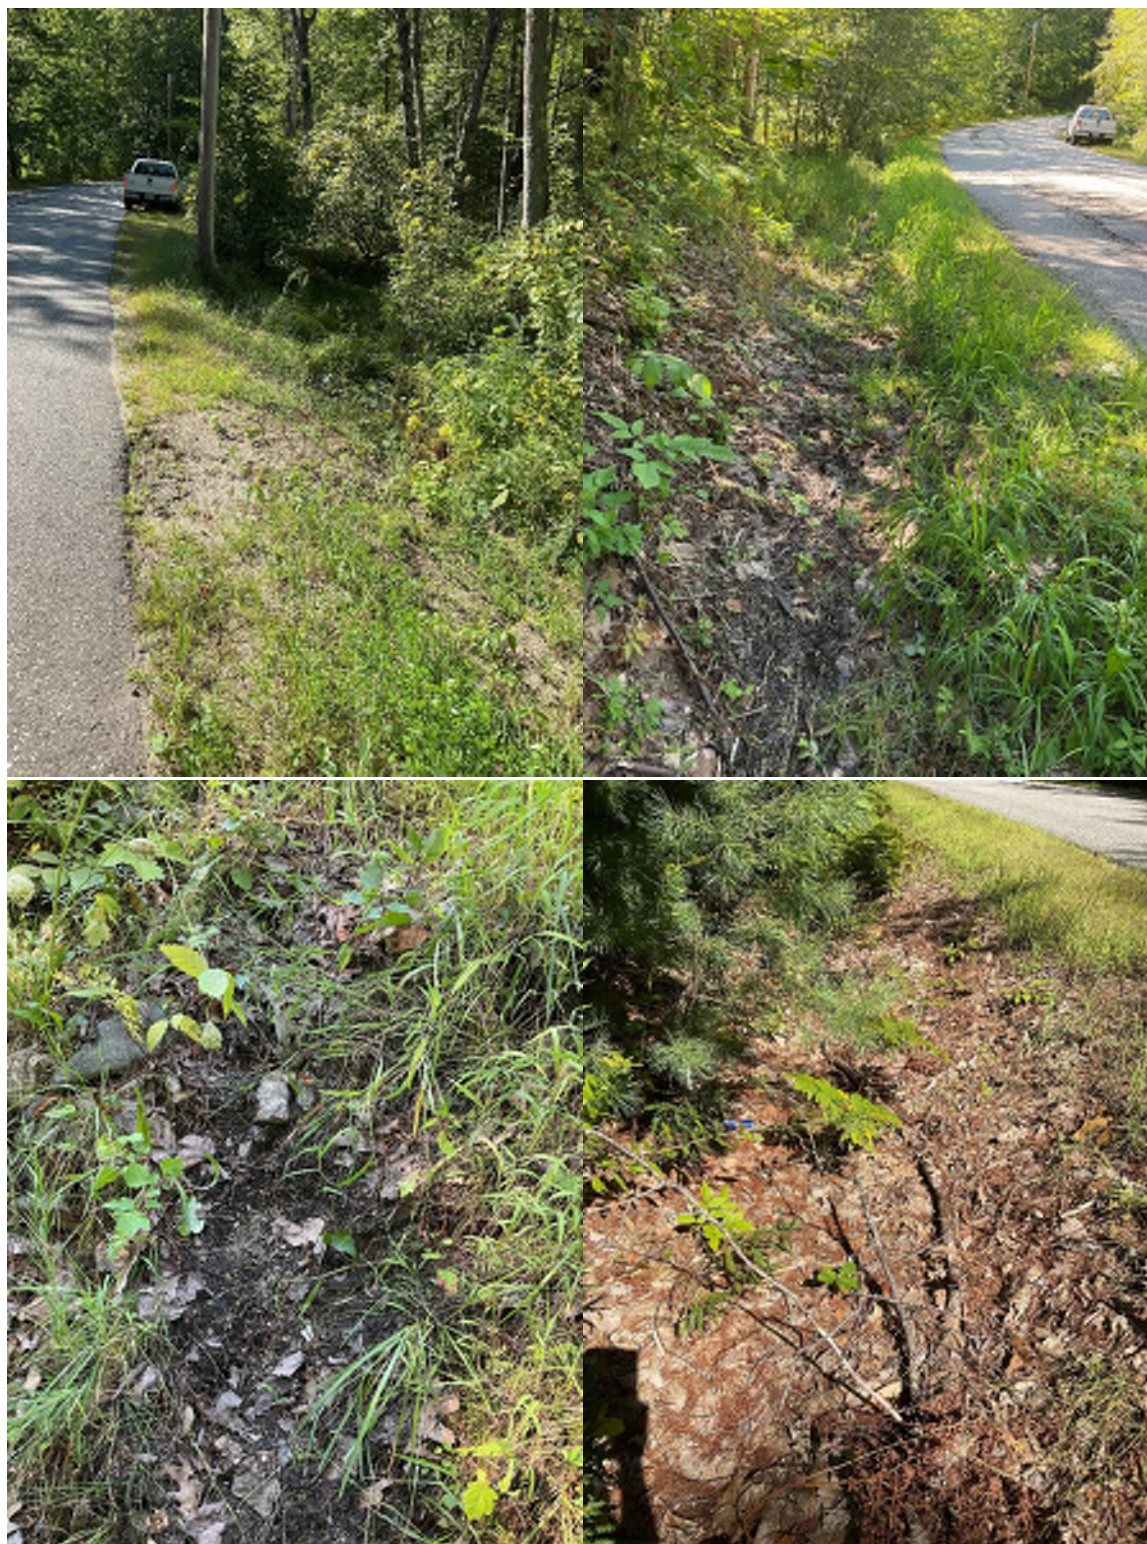
**Figure B-46**

**Little Wilson Pond Exit**

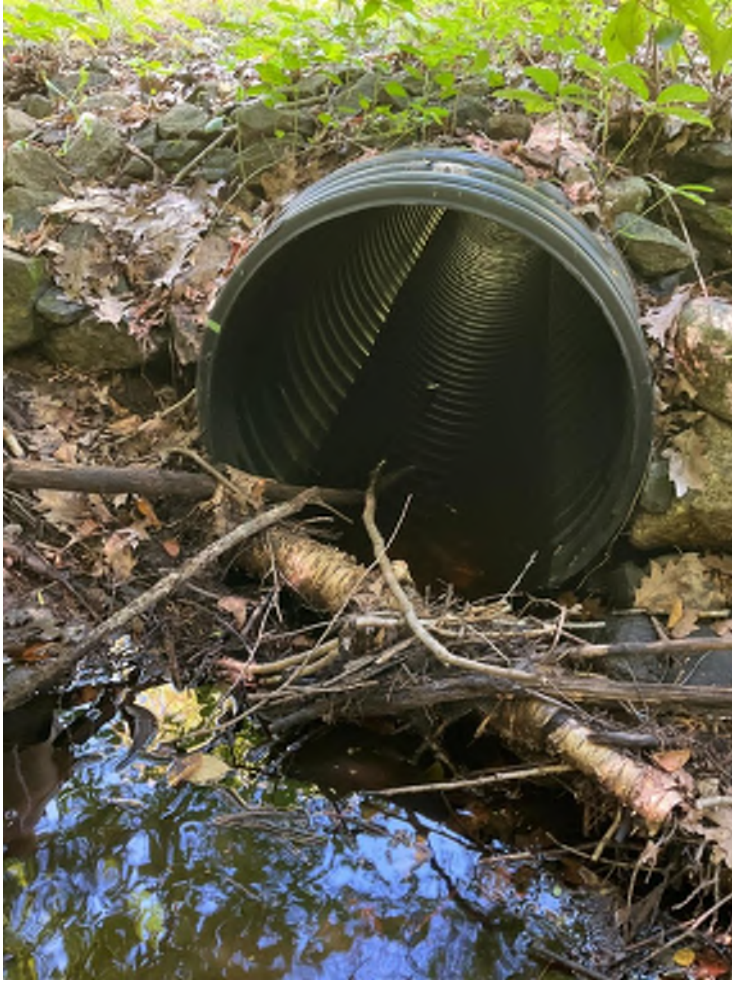
The culvert at UB-11 is located on Wilson Hill Road (downstream of the Skilling Corner Road culvert). At this location there is significant erosion and sediment accumulation in the stream upstream of the culvert entrance, and erosion into the culvert entry (**Figure B-48**). Stream restoration could be considered downstream of this culvert. The culvert at this location was recently replaced, and no evidence of sediment accumulation is present at the exit, and the outlet is well armored with a plunge pool (**Figure B-49**).

**Figure B-49**  
**Exit of Wilson Hill Road Culvert**

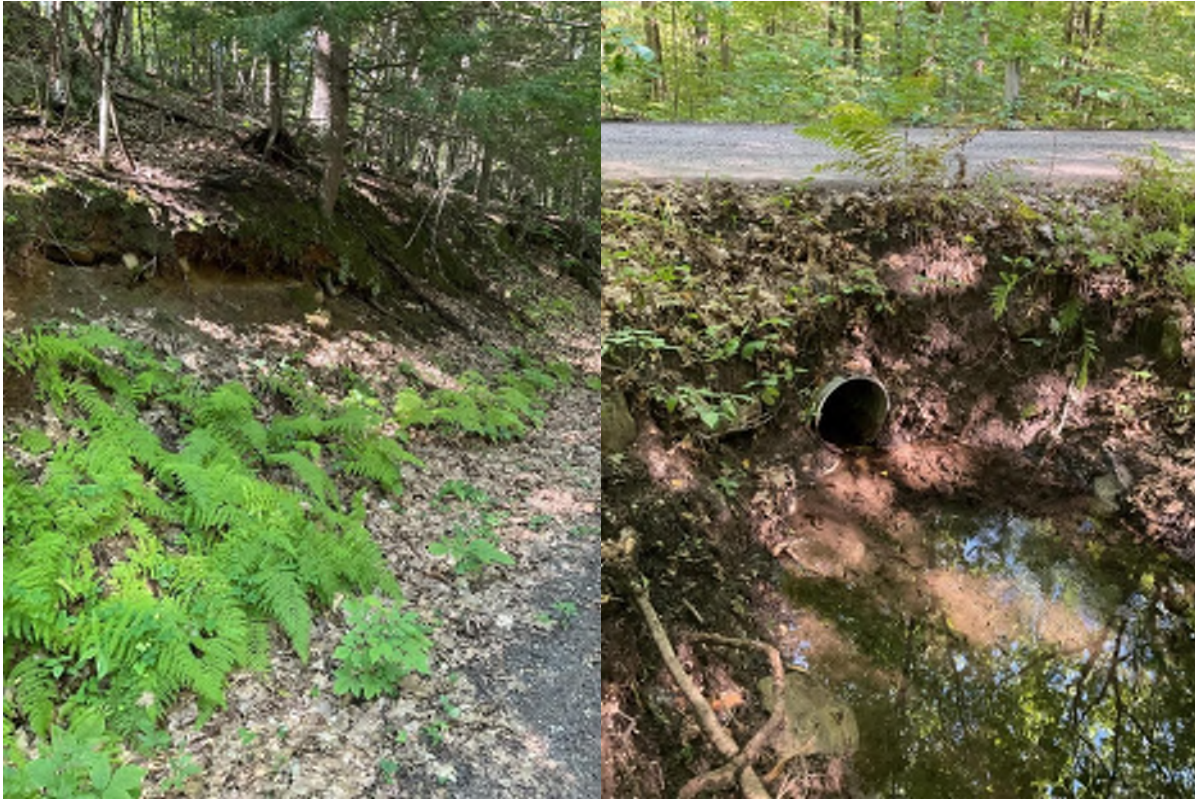
Robinson Road is characterized by steep slopes with significant erosion (**Figure B-51**) along the upslope area to the west and at the culvert crossing to Little Wilson Pond. This area should be stabilized to prevent erosion, and the culvert armored to prevent erosion. In addition, a construction site at the end of Robinson Road is underway without adequate erosion controls. Adequate erosion controls should be implemented at this site.

**Figure B-51**  
**Robinson Road Erosion**

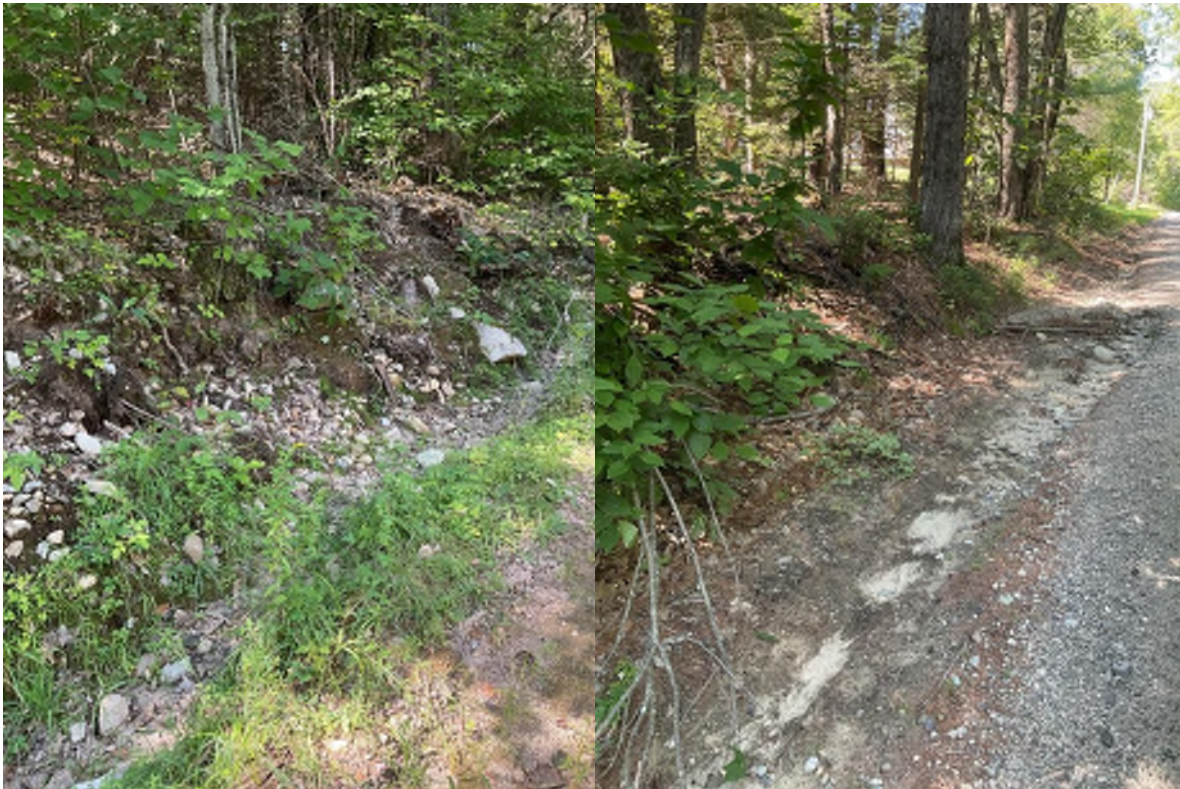
Boutin Road is a dirt road adjacent to Mud Pond. There is severe erosion of the road surface and the steep slopes adjacent to the road (**Figure B-53**). Furthermore, this area was recently developed, and additional attention to erosion controls and nutrient reduction into Mud Pond should be considered.

**Figure B-53**  
Erosion on Boutin Road and Adjacent Steep Slopes

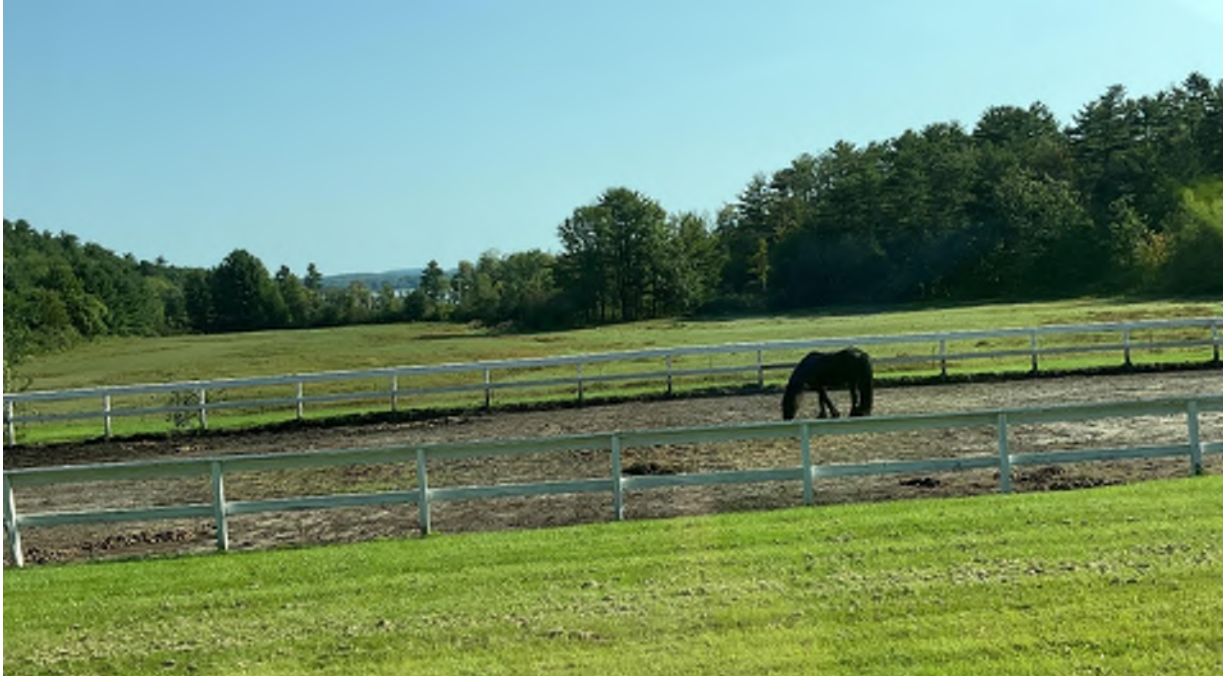
One active farm was observed during the 2022 watershed survey on Youngs Corner Road. This farm has horses (**Figure B-56**). AWD/LWD staff indicated that this farm has had sound manure management practices in the past. Continued education and monitoring of this property should occur, especially given this farm's close proximity to Lake Auburn.

**Figure B-56**  
**Farm on Youngs Corner Road**

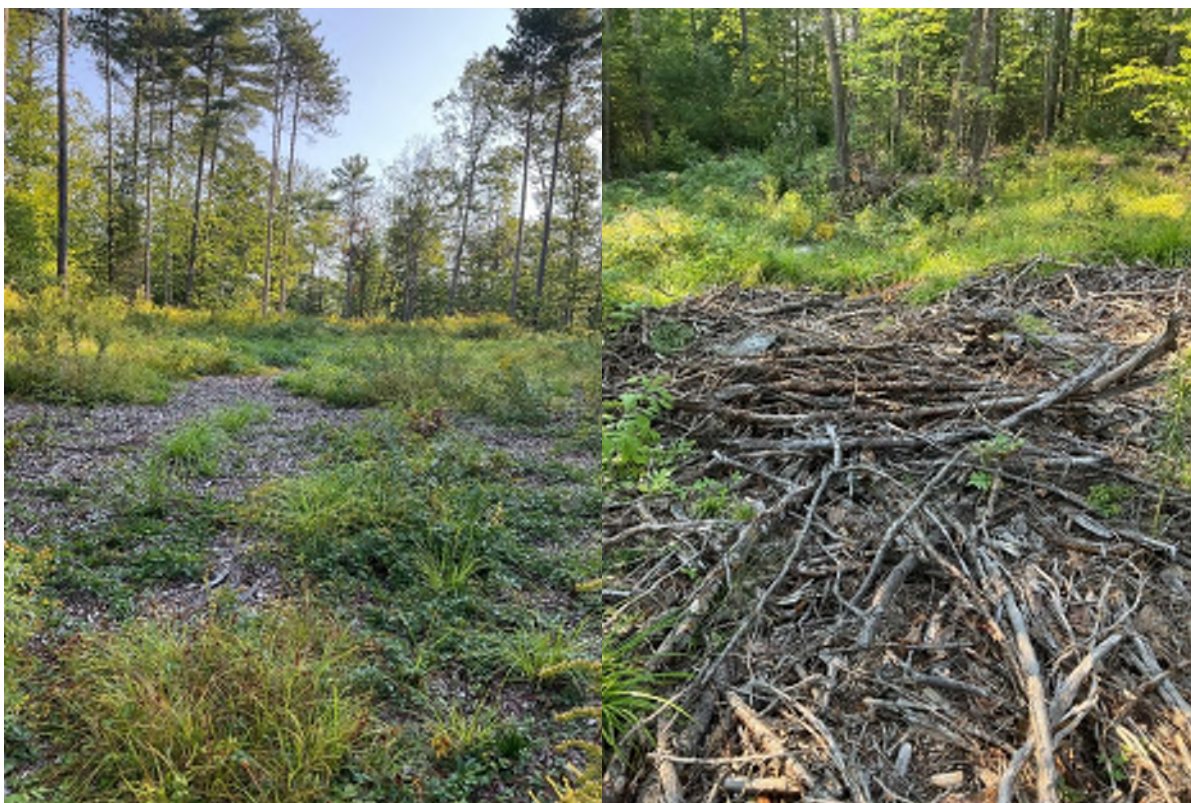
The 2022 watershed survey included a visit to a LAWPC property on Summer Street that was logged in winter 2020. The conditions at the site were generally good, with no evidence of erosion towards the lake. The staging area is fairly large and clear cut, with a mixture of chipped wood and slash providing erosion control (**Figure B-57**); additional skid trails were cut radially outward from the staging area (**Figure B-58**).

**Figure B-57**  
**Staging Area**

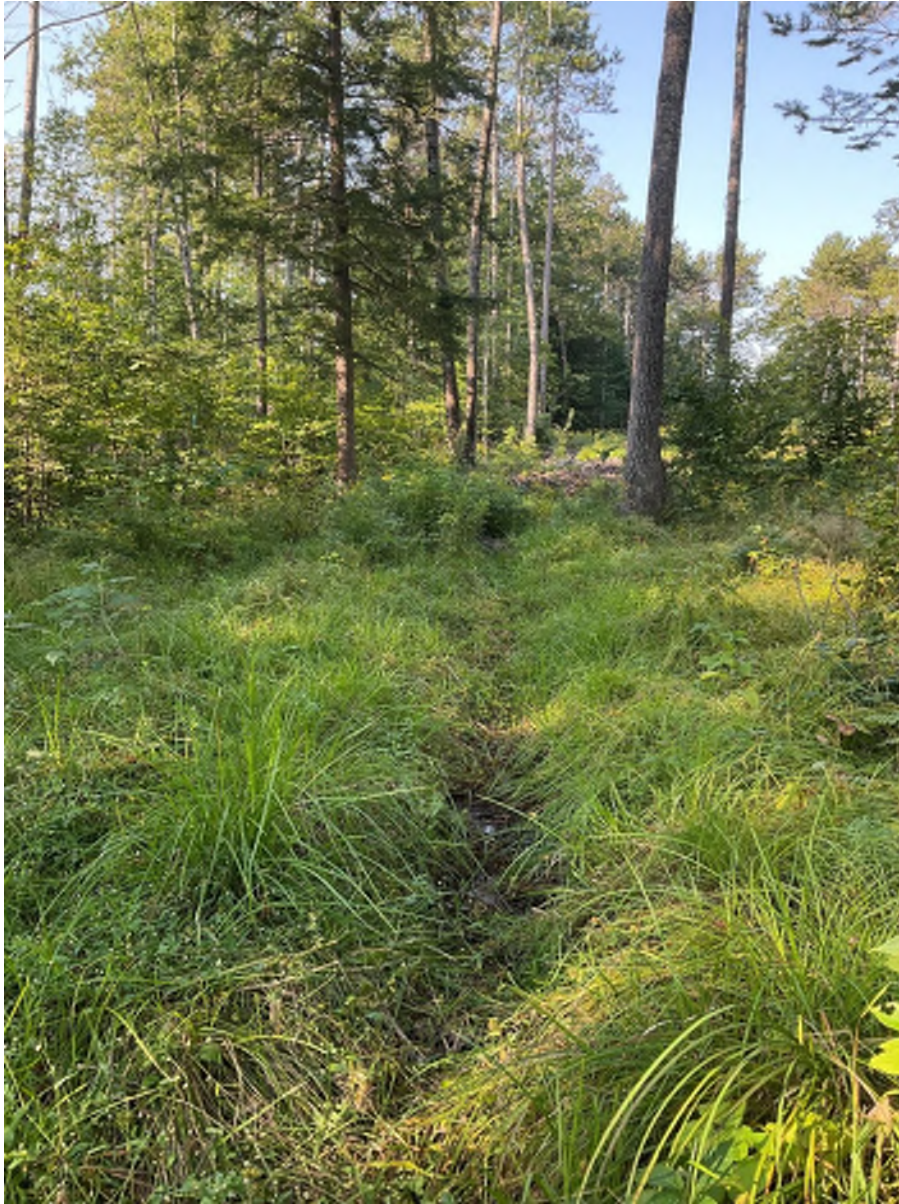
**Figure B-58**  
Timber Operation on LAWPC Land in Winter 2020 showing Skid Trail Leaving Staging Area

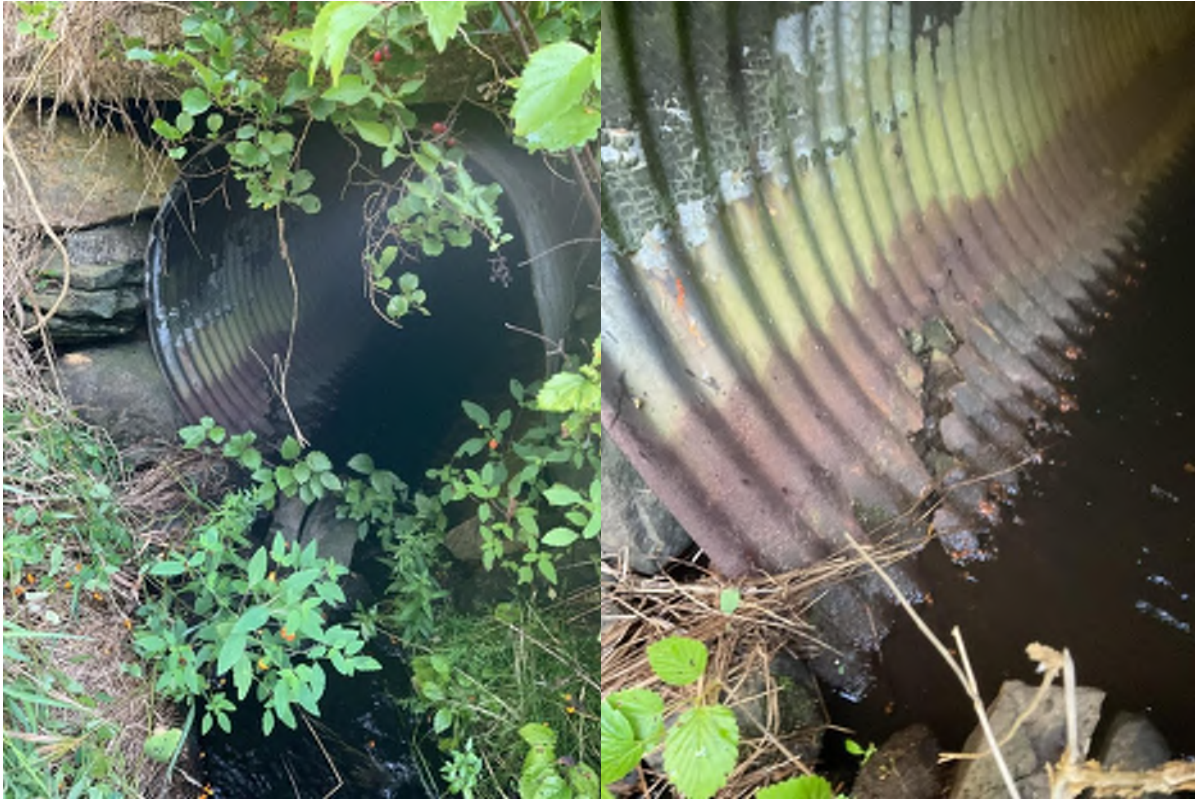
A culvert crossing on Summer St adjacent to Lake Auburn is beginning to fail, with the corrugated metal culvert corroding on the bottom at the exit. The outlet is well-armored, with no evidence of erosion. This culvert should be considered for replacement, and if possible, a plunge pool added to reduce sediment transport given the close proximity of this culvert to Lake Auburn. (**Figure B-59**).

**Figure B-59**  
**Summer Street Culvert**

| ID | Watershed | Description | Recommendations | Severity | High-Priority BMP | Coordinates |
|---|---|---|---|---|---|---|
| L-3 | Lower Watershed | Culvert on Summer Street is corroding | Replace culvert and consider a plunge pool to reduce sediment transport to Lake Auburn | Low | No | -70.25914, 44.12299 |

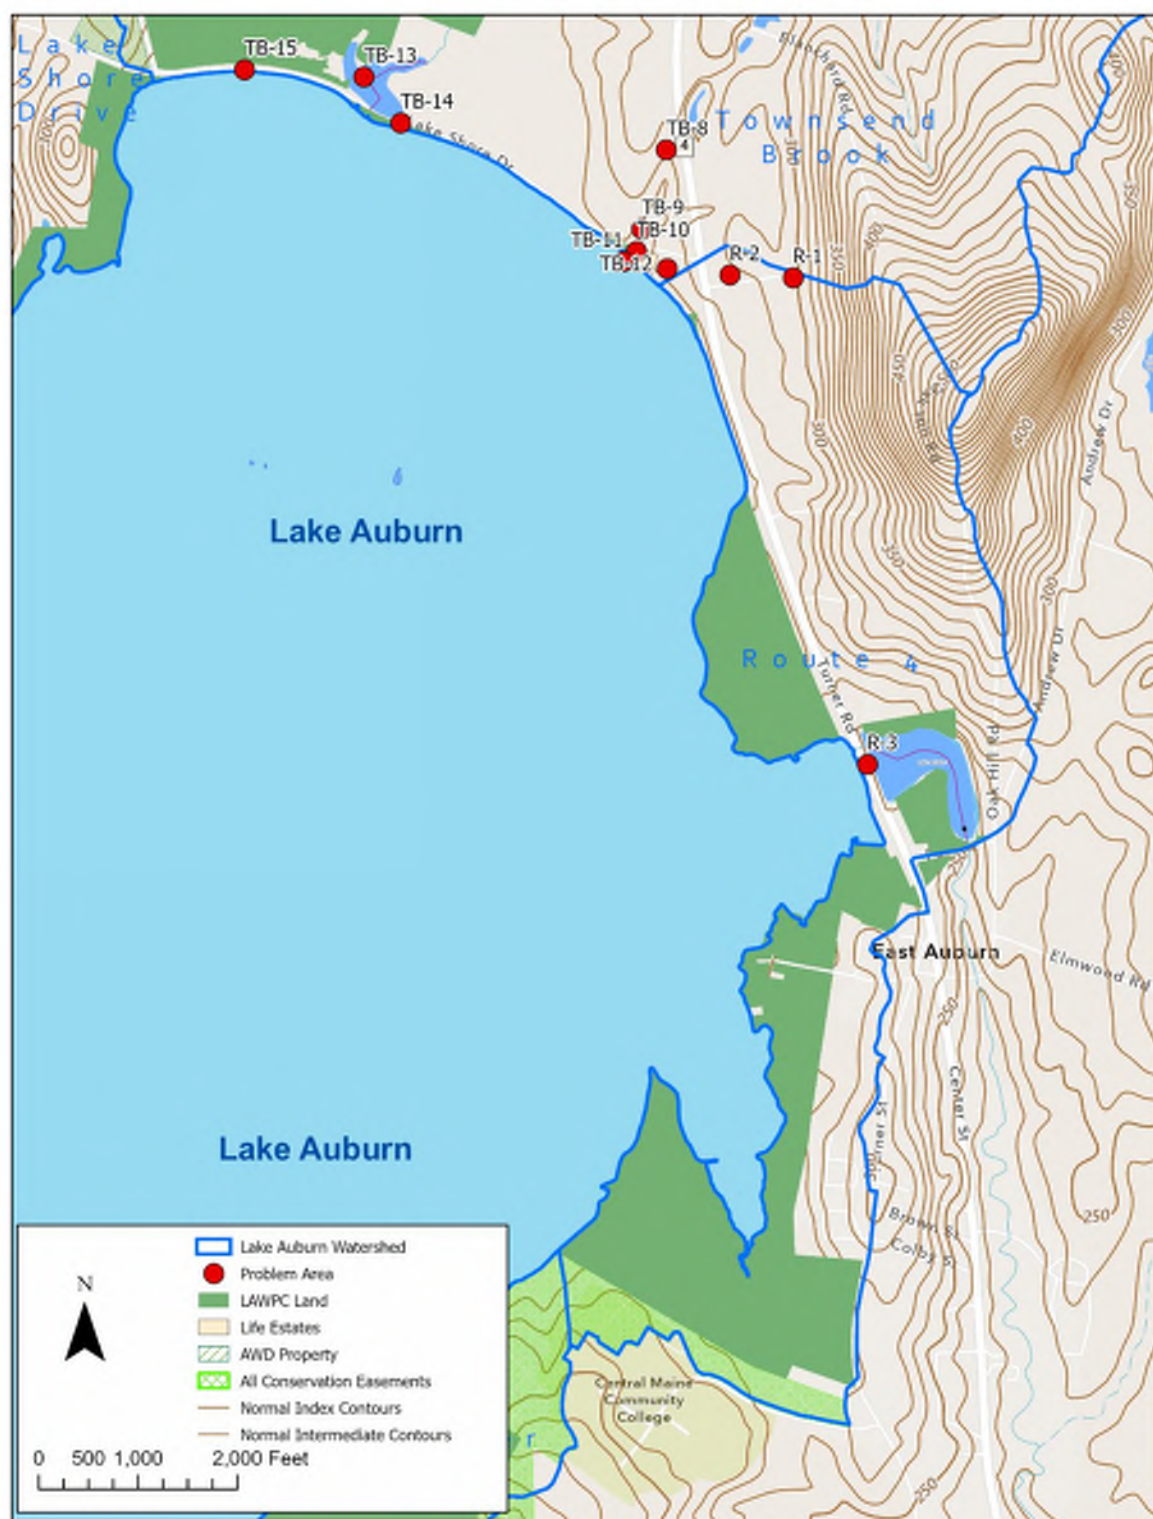
- Direct drainage and lack of guard rails on the Route 4 causeway
- Logging and construction at the northern end of the Route 4 drainage

**Figure B-60**  
**Route 4 Pollution Sources**

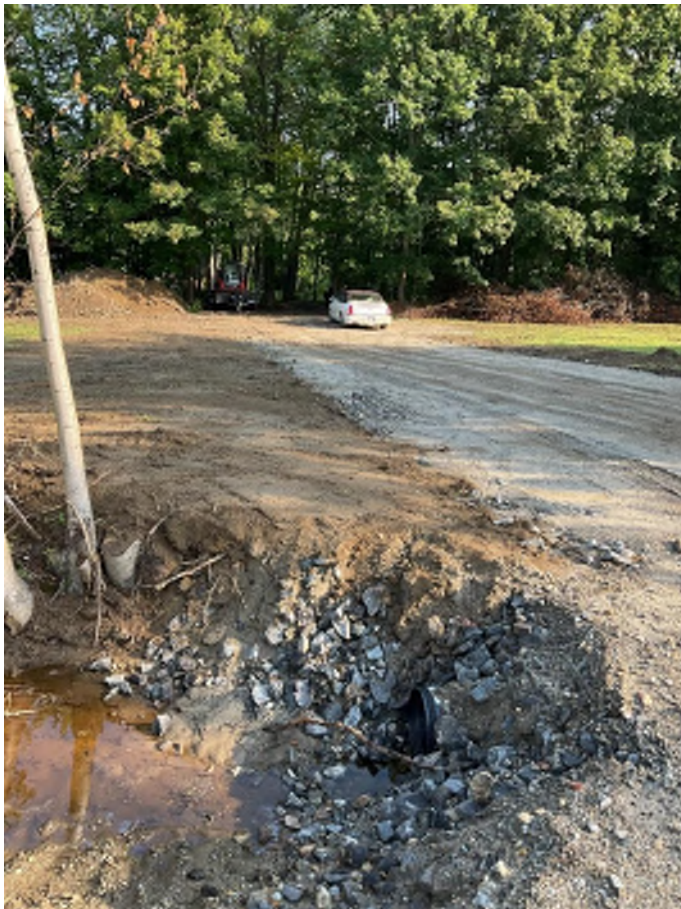
A residence on Hathaway Street recently constructed a driveway without adequate erosion controls (**Figure B-61**). Given the proximity to the lake, LAWPC should work with the landowner to implement erosion controls and reduce the potential for additional erosion once the development is complete. However, the drainage from this location discharges to the newly constructed armored swale on Route 4 and then to a vortex unit, so the water quality impact of this location is mitigated by these downstream controls.

**Figure B-61**  
Construction on Hathaway Road

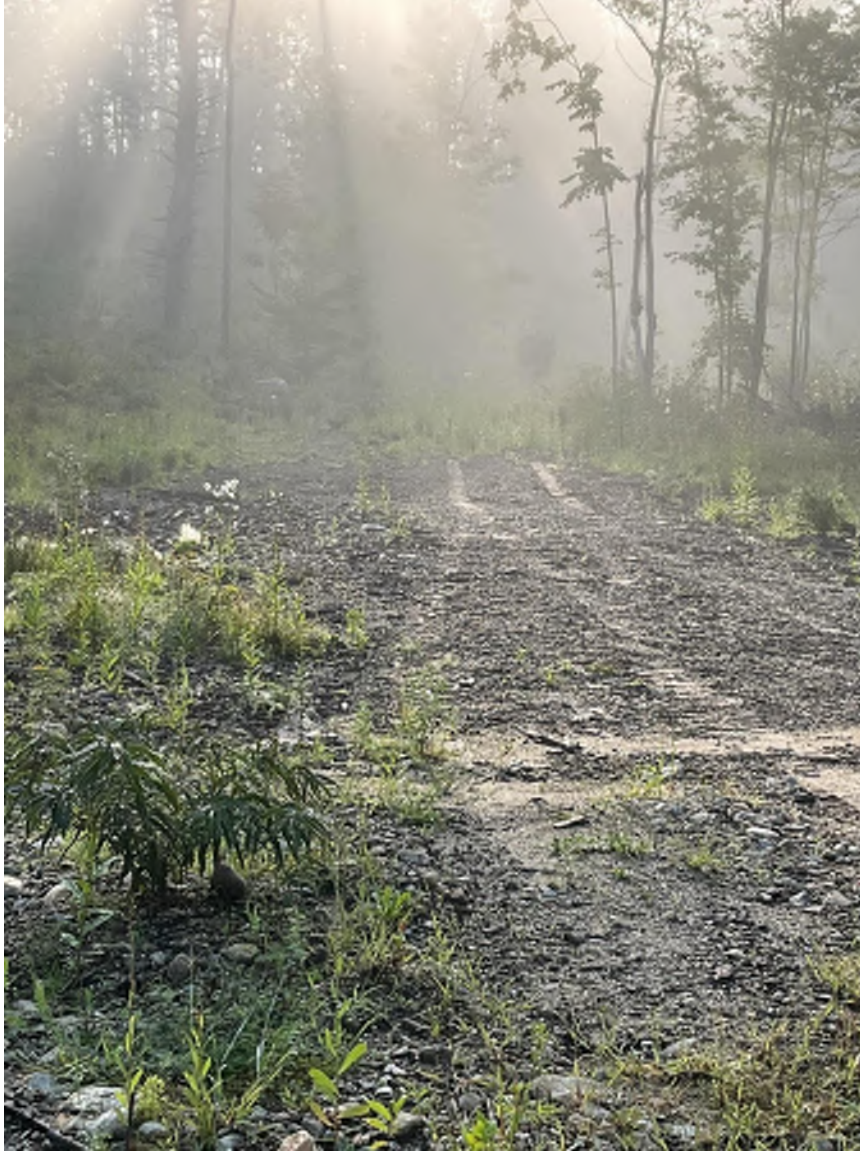
A private logging operation at the end of Hathaway St was completed with generally poor erosion controls (**Figure B-62**) prior to the property being offered for sale. LAWPC should work with the current and future landowners to implement improved erosion controls on this property.

**Figure B-62**  
**Logging Operation on Hathaway Street**
